Joint Deterioration Causes and Solutions

KU Asphalt Conference 2023

Ross Weber | KU Conference 2023

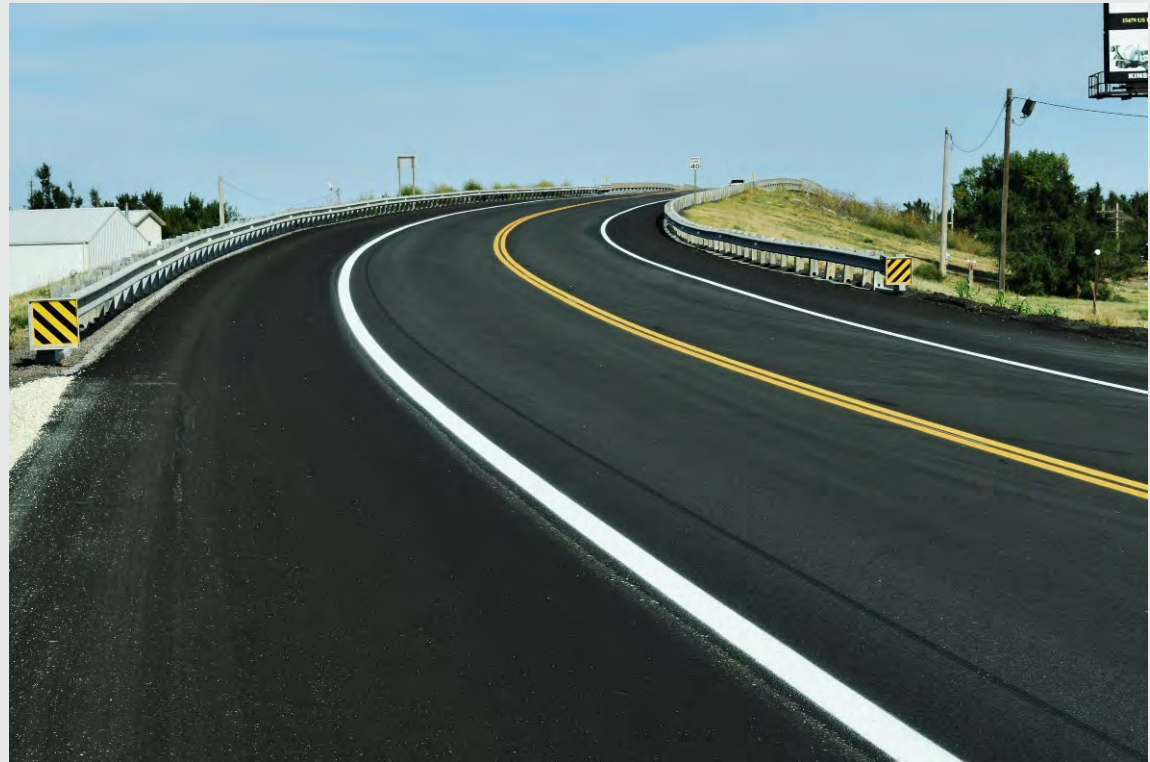
What is a primary joint crack?

Interface between first and second pass of paver

- Damage at the joint caused by roller
- Low Density
- Poor drainage
- Mix prone to stripping
- Matching to tight

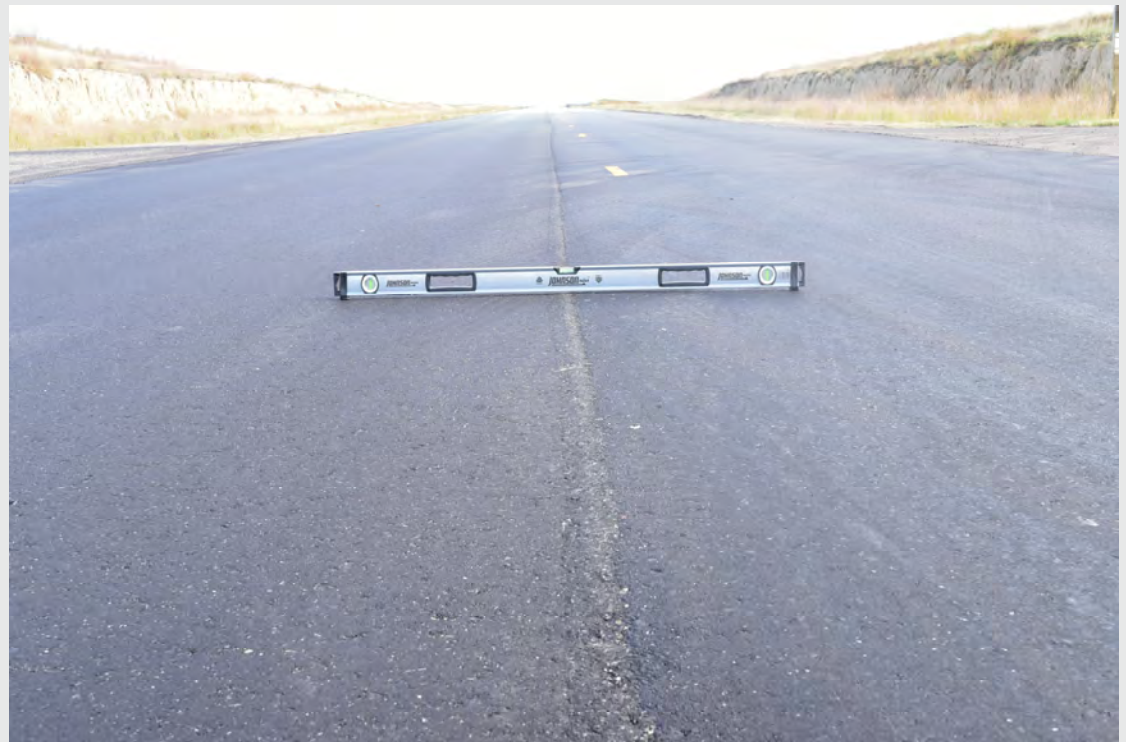
Primary joint crack

Interface between first and second pass of paver

- Damage at the joint caused by roller
- Low Density
- Poor drainage
- Mix prone to stripping
- Matching to tight

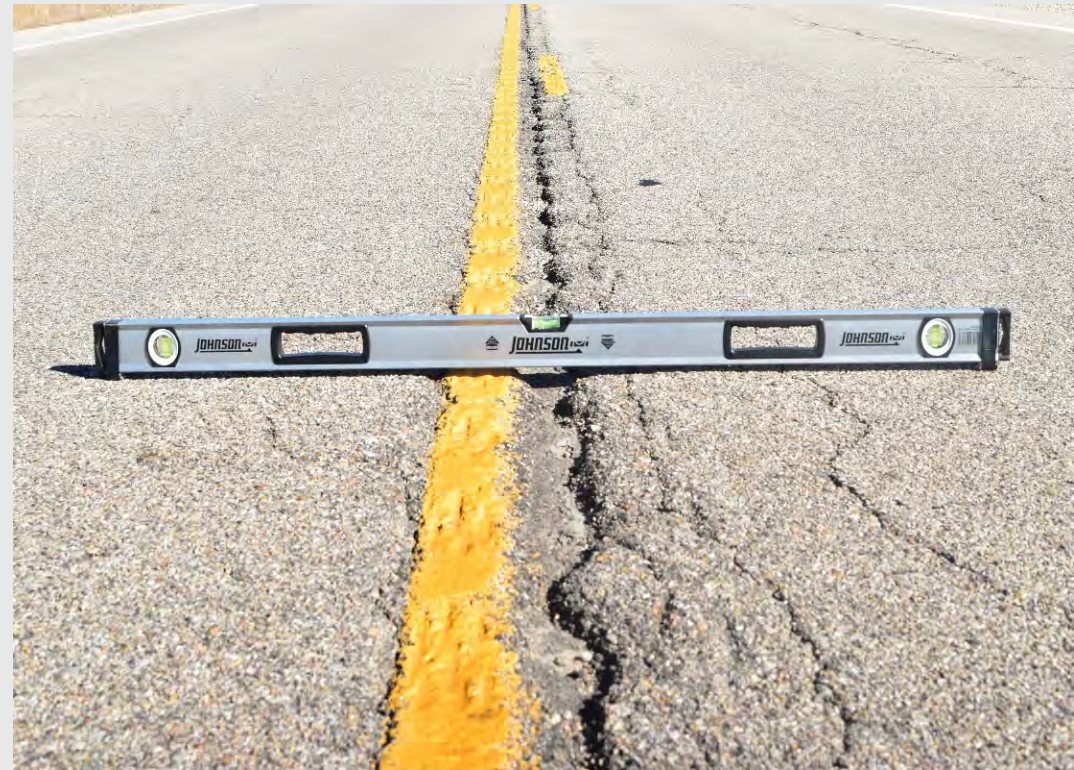
Primary joint crack

Interface between first and second pass of paver

- Damage at the joint caused by roller
- Low Density
- Poor drainage
- Mix prone to stripping
- Matching to tight

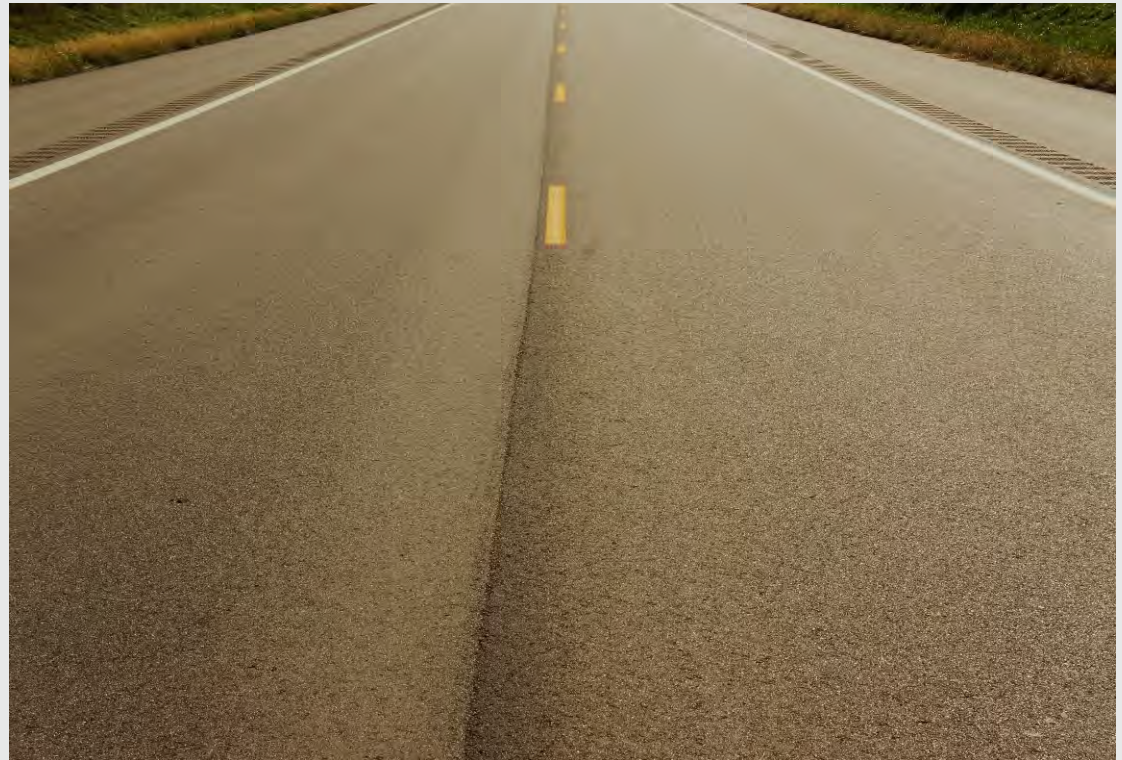
Primary joint crack

Interface between first and second pass of paver

- Damage at the joint caused by roller
- Low Density
- Poor drainage
- Mix prone to stripping
- Matching to tight

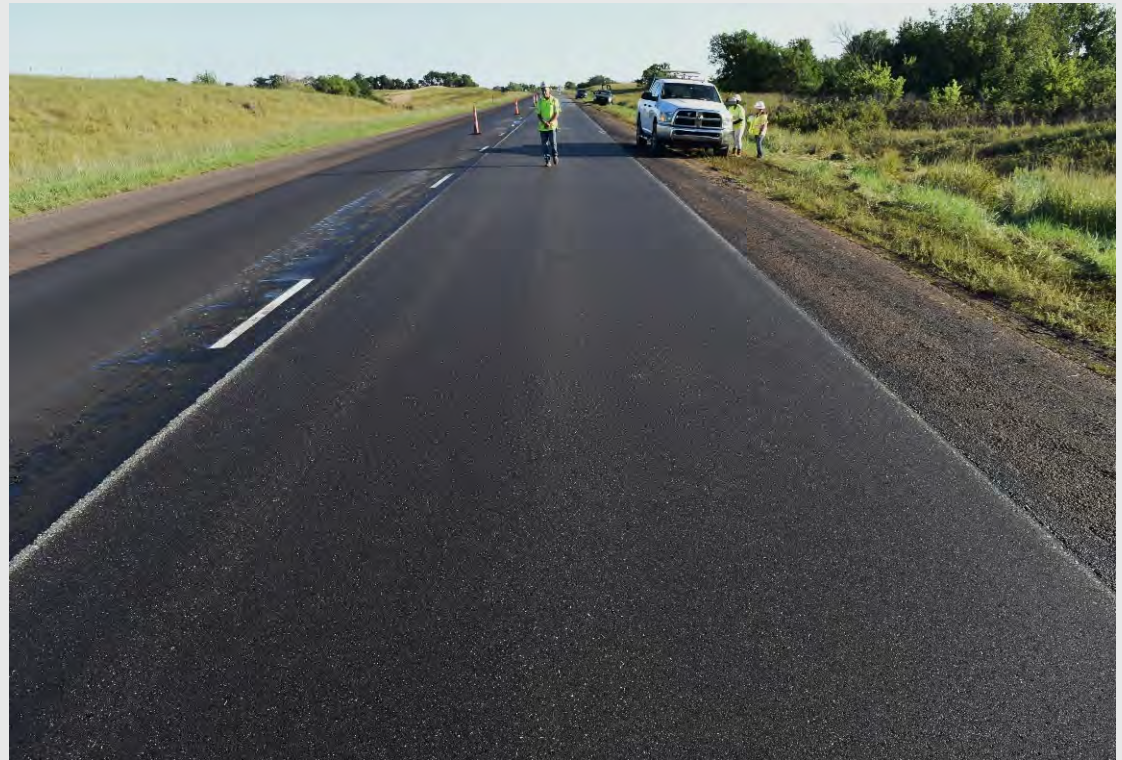
Primary joint crack

Interface between first and second pass of paver

- Damage at the joint caused by roller
- Low Density
- Poor drainage
- Mix prone to stripping
- Matching to tight

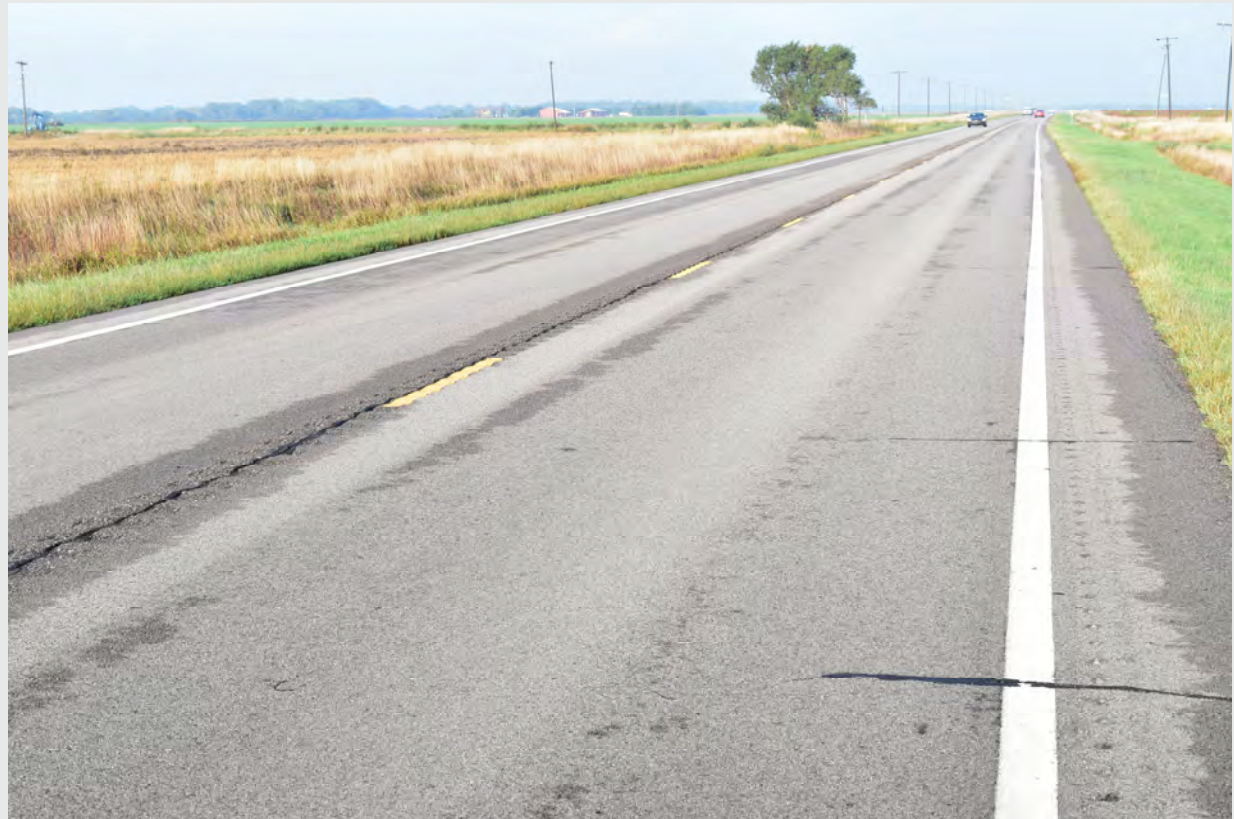
Secondary joint crack

- Secondary Joint Crack (Near Joint)
 - Damage near joint caused by roller
 - Low density
 - Poor drainage
 - Mix prone to stripping
 - Irregular density caused by screed set-up
 - Edge of Stripe

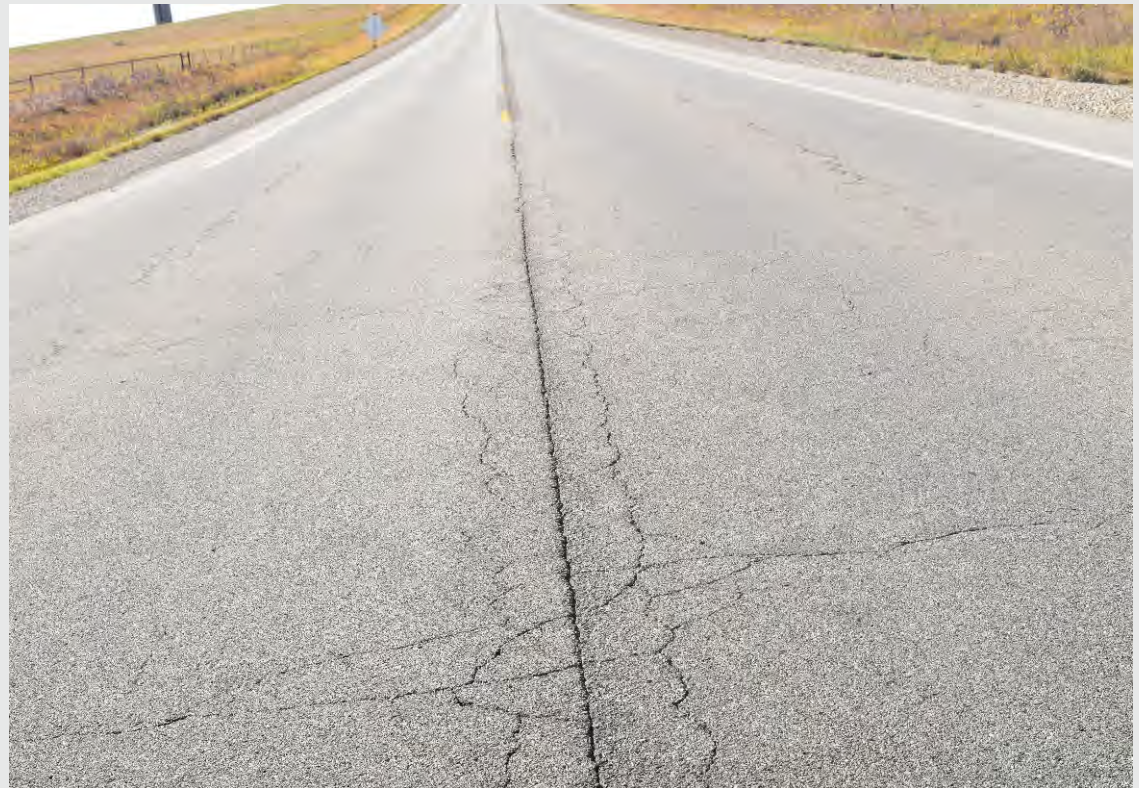
Secondary joint crack

- Secondary Joint Crack (Near Joint)
 - Damage near joint caused by roller
 - Low density
 - Poor drainage
 - Mix prone to stripping
 - Irregular density caused by screed set-up
 - Edge of Stripe

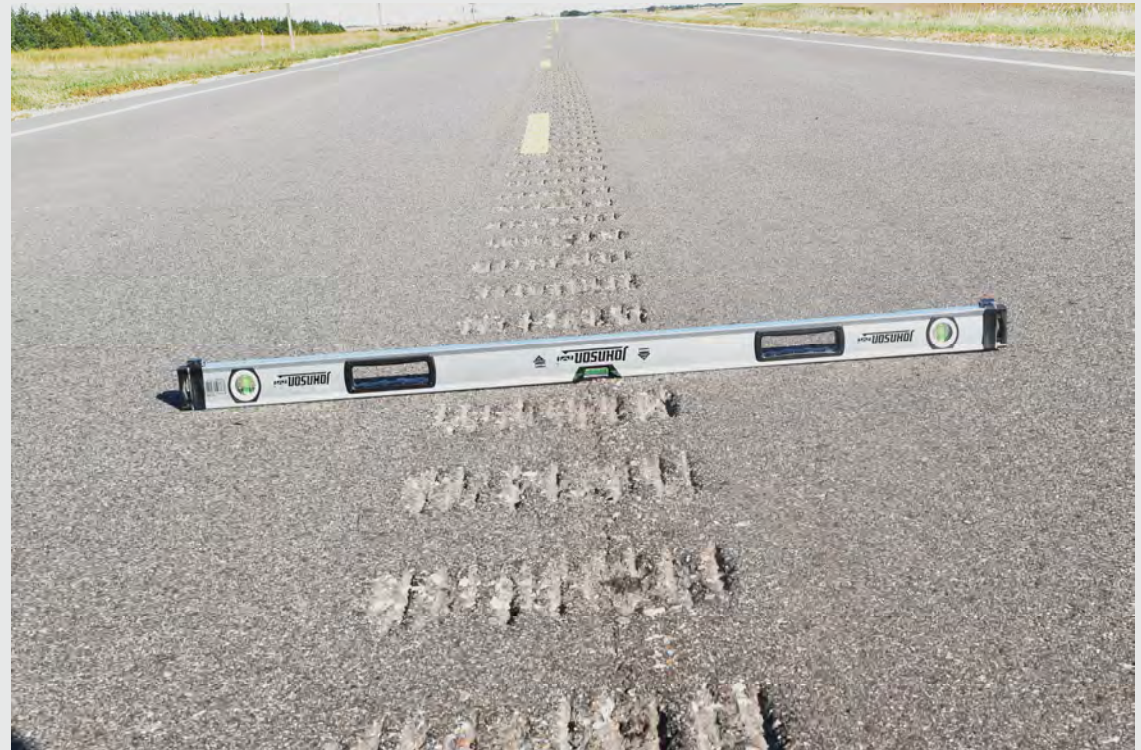
Secondary joint crack

- Secondary Joint Crack (Near Joint)
 - Damage near joint caused by roller
 - Low density
 - Poor drainage
 - Mix prone to stripping
 - Irregular density caused by screed set-up
 - Edge of Stripe

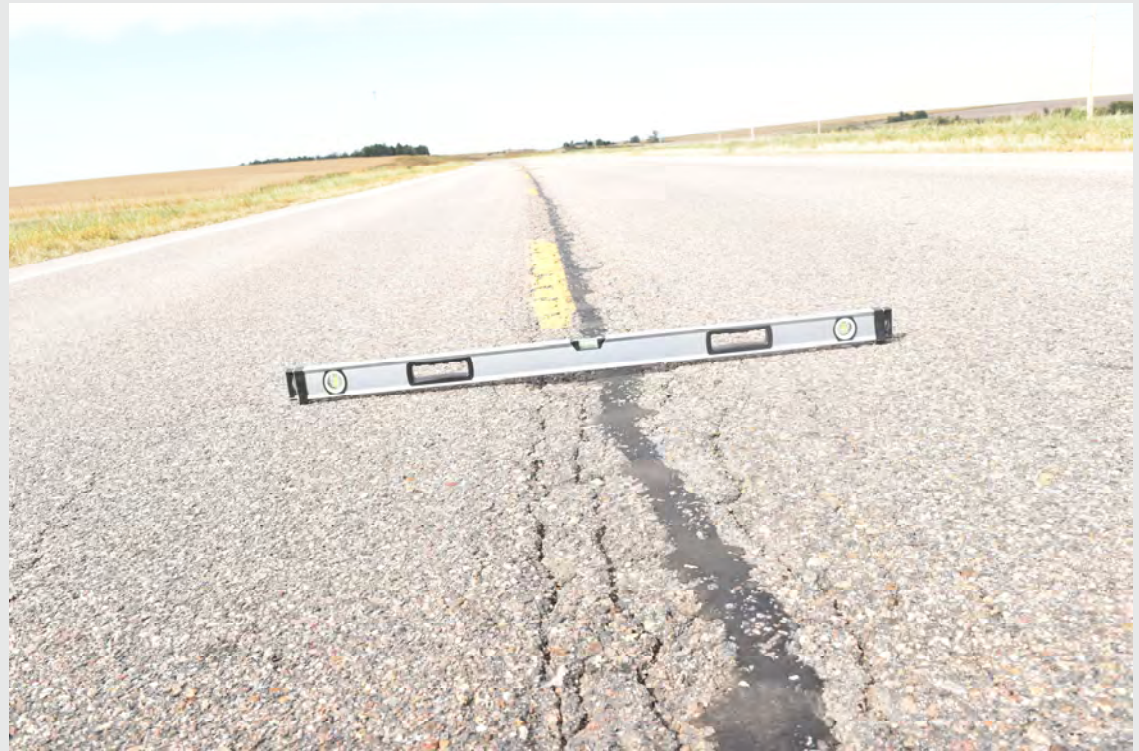
Secondary joint crack

- Secondary Joint Crack (Near Joint)
 - Damage near joint caused by roller
 - Low density
 - Poor drainage
 - Mix prone to stripping
 - Irregular density caused by screed set-up
 - Edge of Stripe

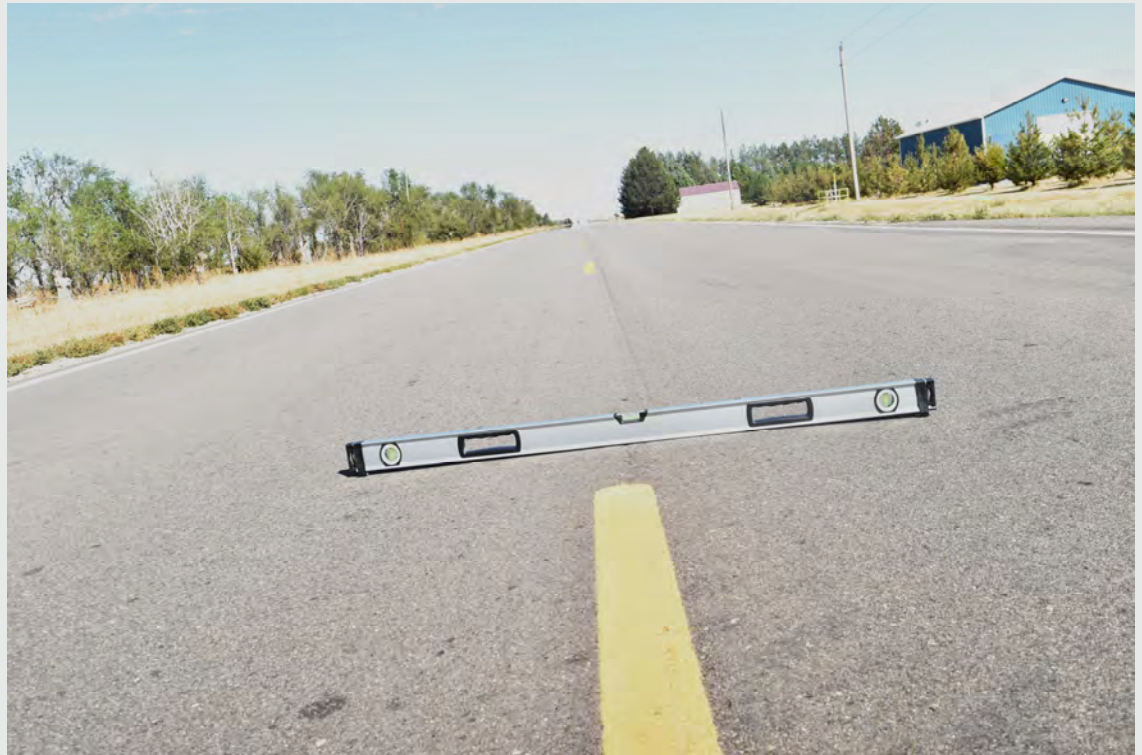
Secondary joint crack

- Secondary Joint Crack (Near Joint)
 - Damage near joint caused by roller
 - Low density
 - Poor drainage
 - Mix prone to stripping
 - Irregular density caused by screed set-up
 - Edge of Stripe

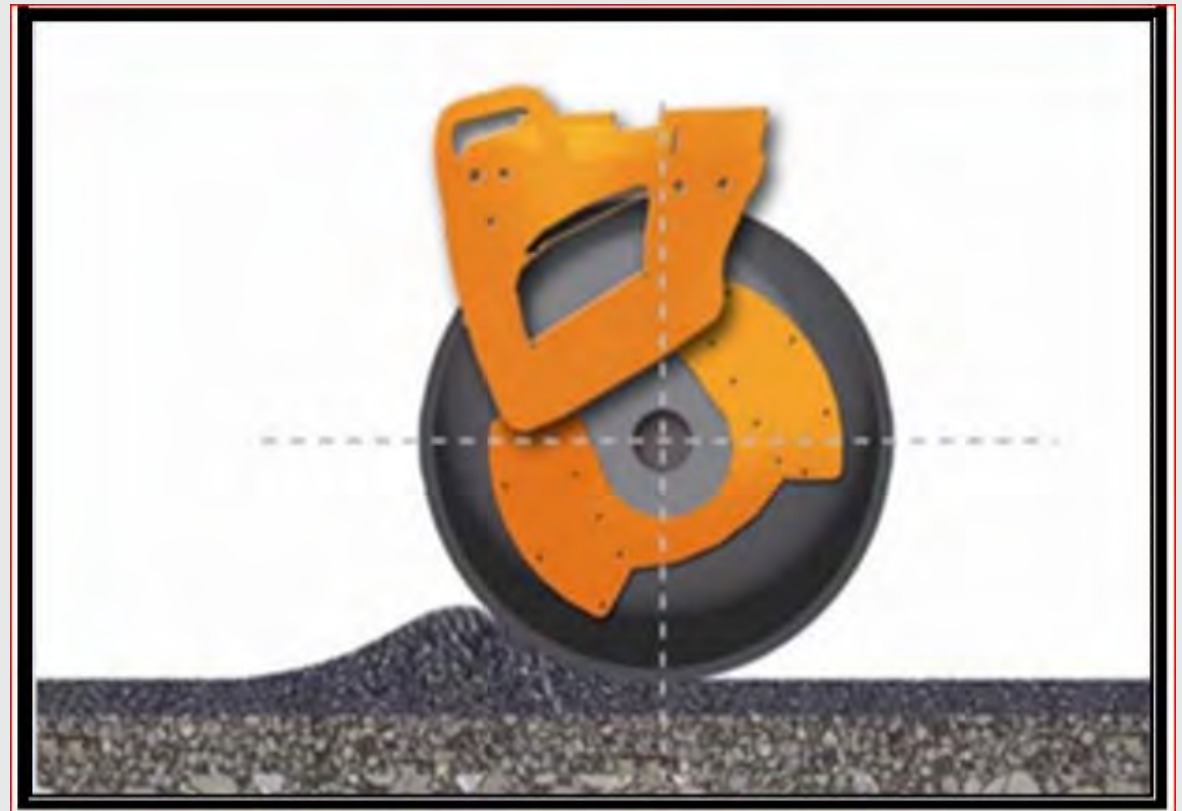
Secondary joint crack

- Secondary Joint Crack (Near Joint)
 - Damage near joint caused by roller
 - Low density
 - Poor drainage
 - Mix prone to stripping
 - Irregular density caused by screed set-up
 - Edge of Stripe

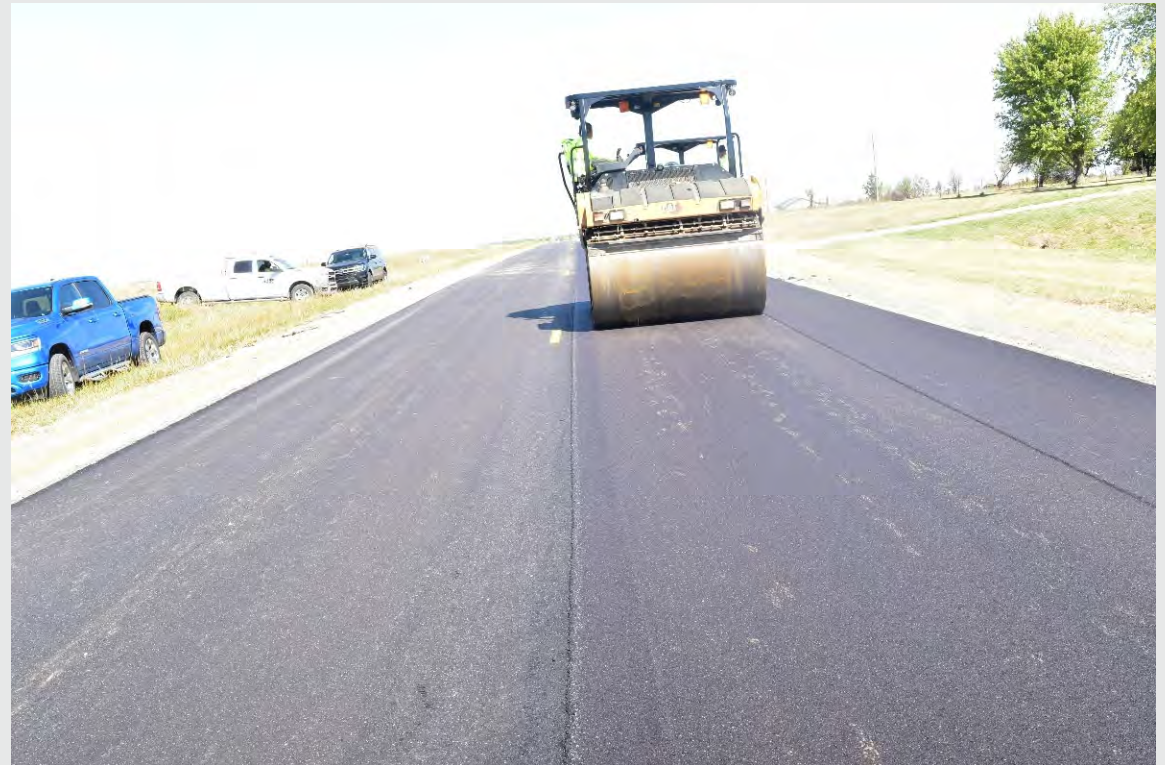
Secondary joint crack

- Secondary Joint Crack (Near Joint)
 - Damage near joint caused by roller
 - Low density
 - Poor drainage
 - Mix prone to stripping
 - Irregular density caused by screed set-up
 - Edge of Stripe

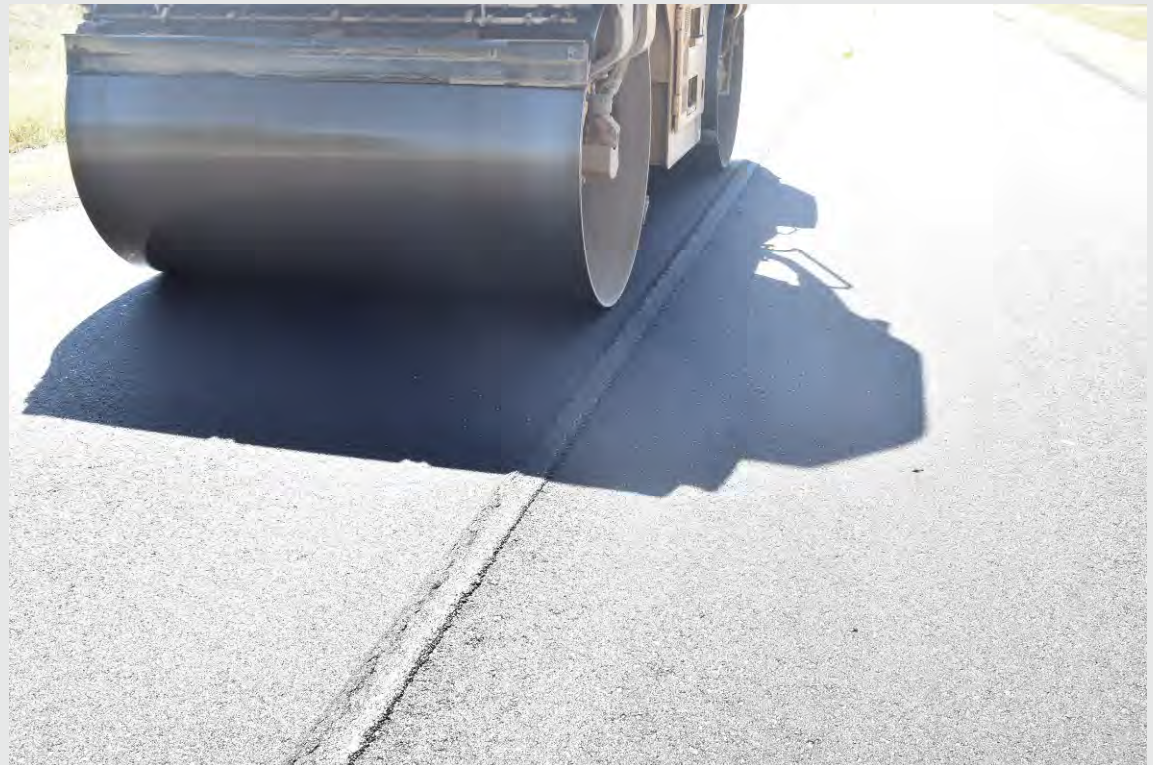
Secondary joint crack

- Secondary Joint Crack (Near Joint)
 - Damage near joint caused by roller
 - Low density
 - Poor drainage
 - Mix prone to stripping
 - Irregular density caused by screed set-up
 - Edge of Stripe

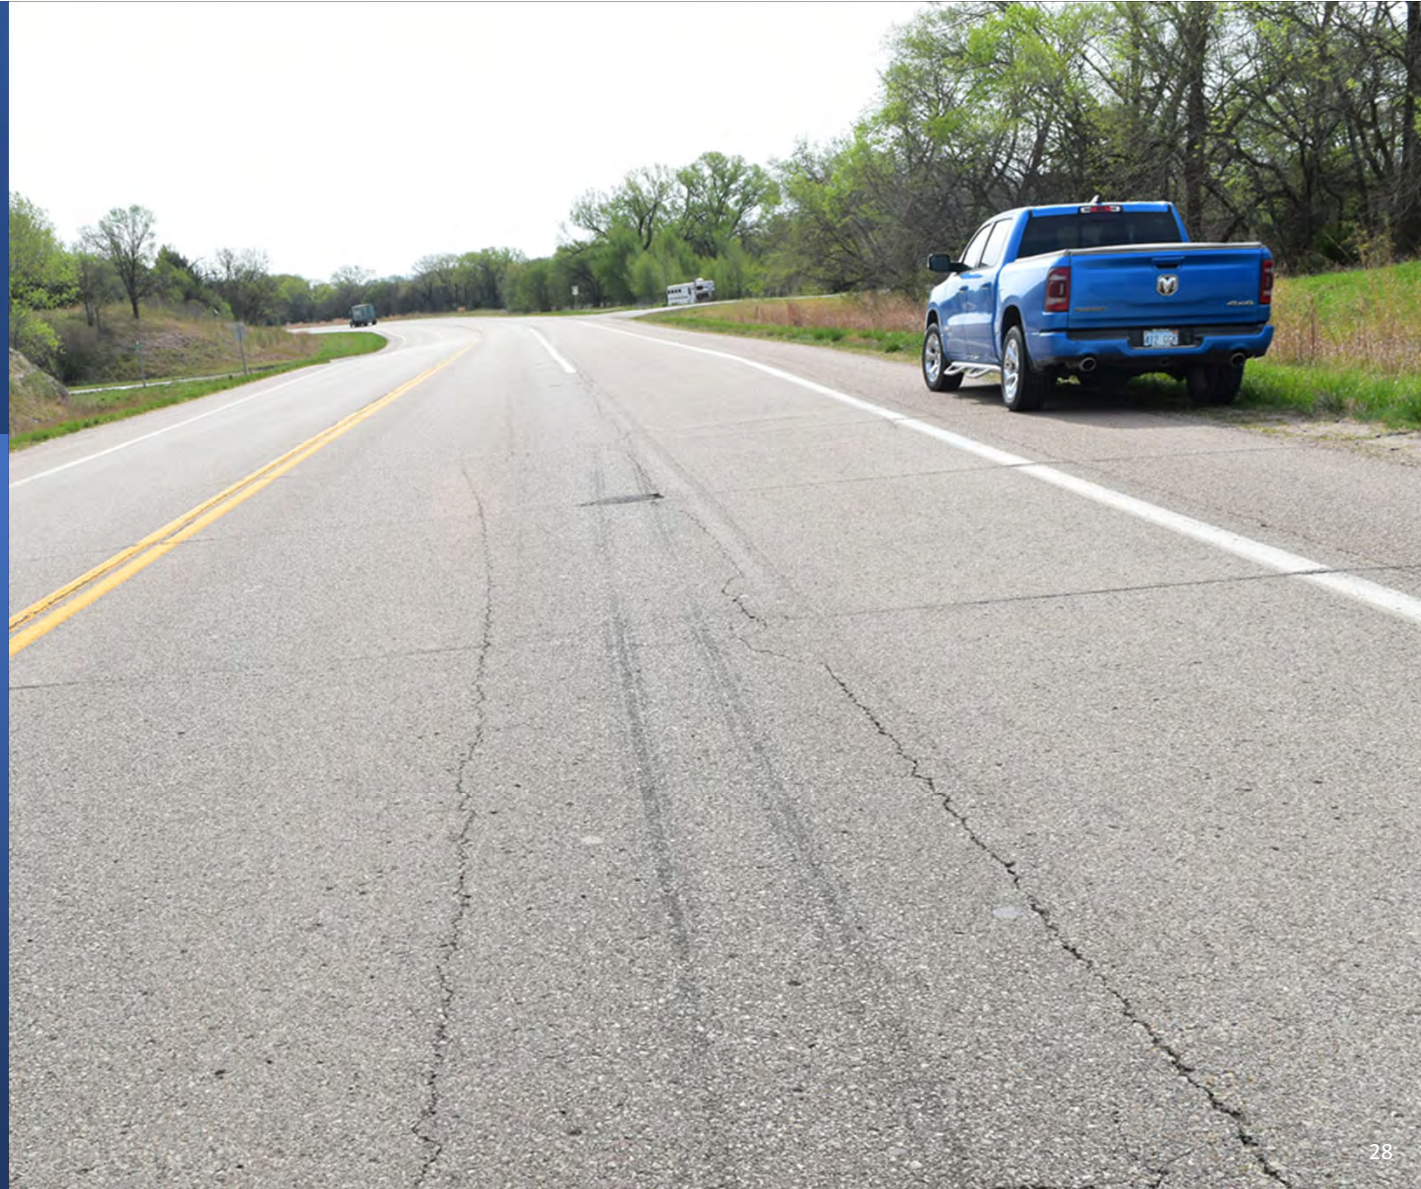
Roller turn damage in paved surface

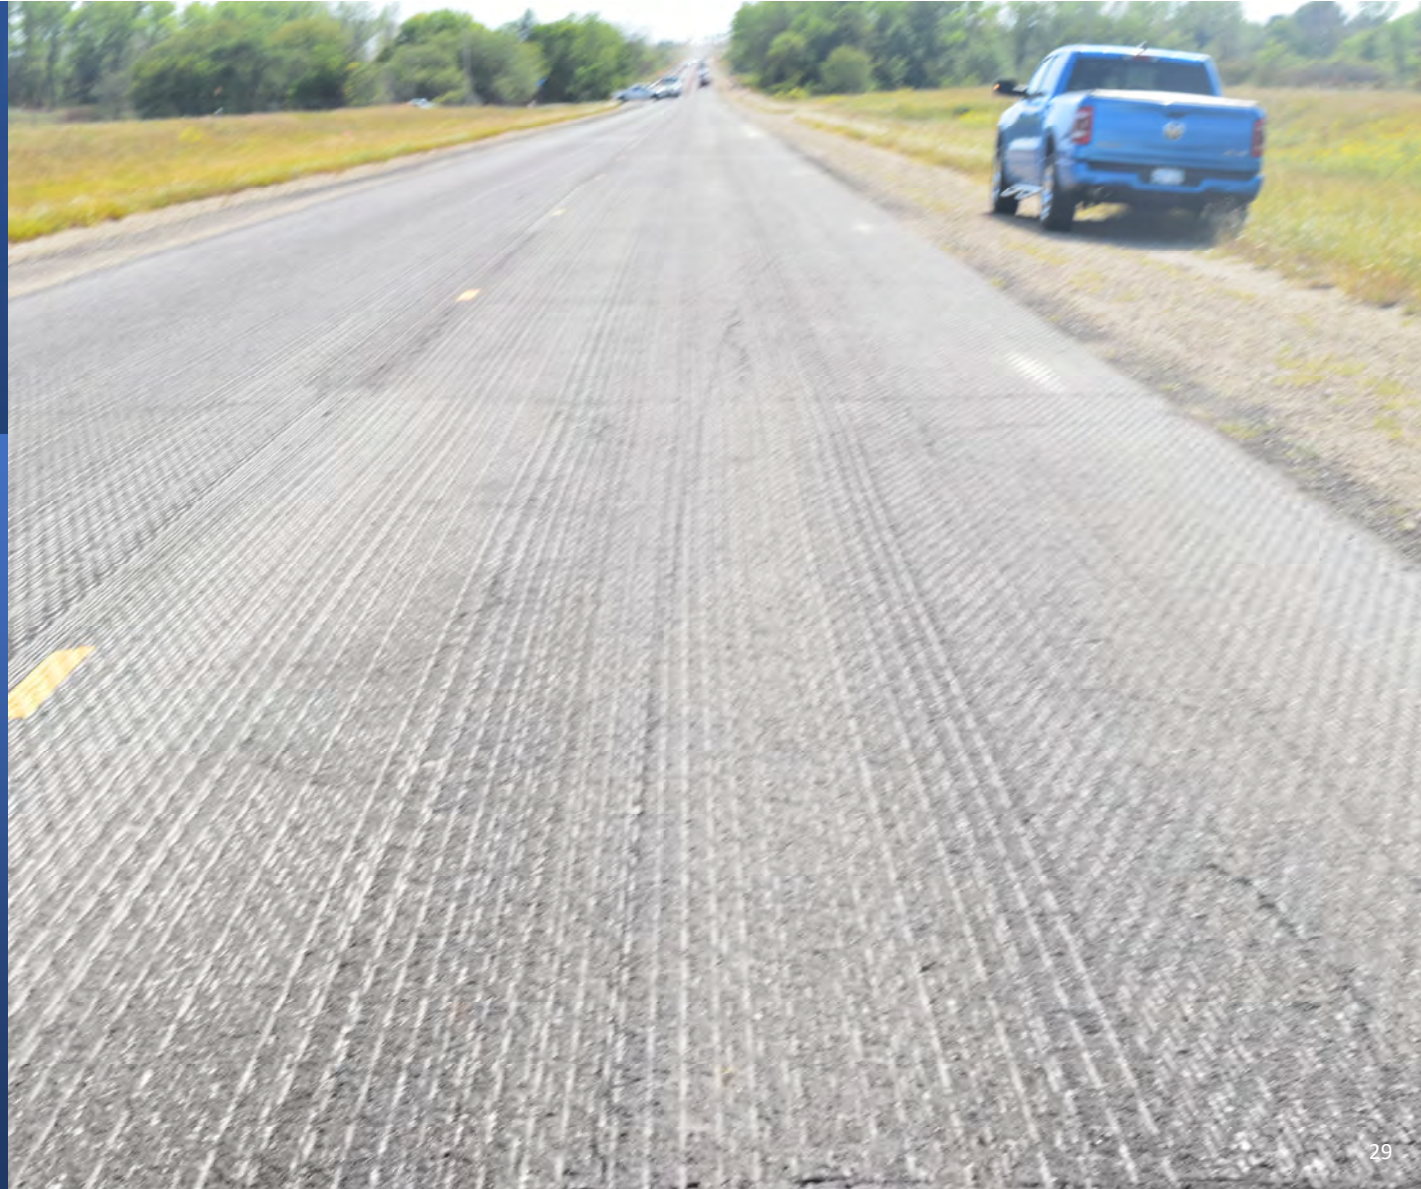
Roller turn damage in milled surface

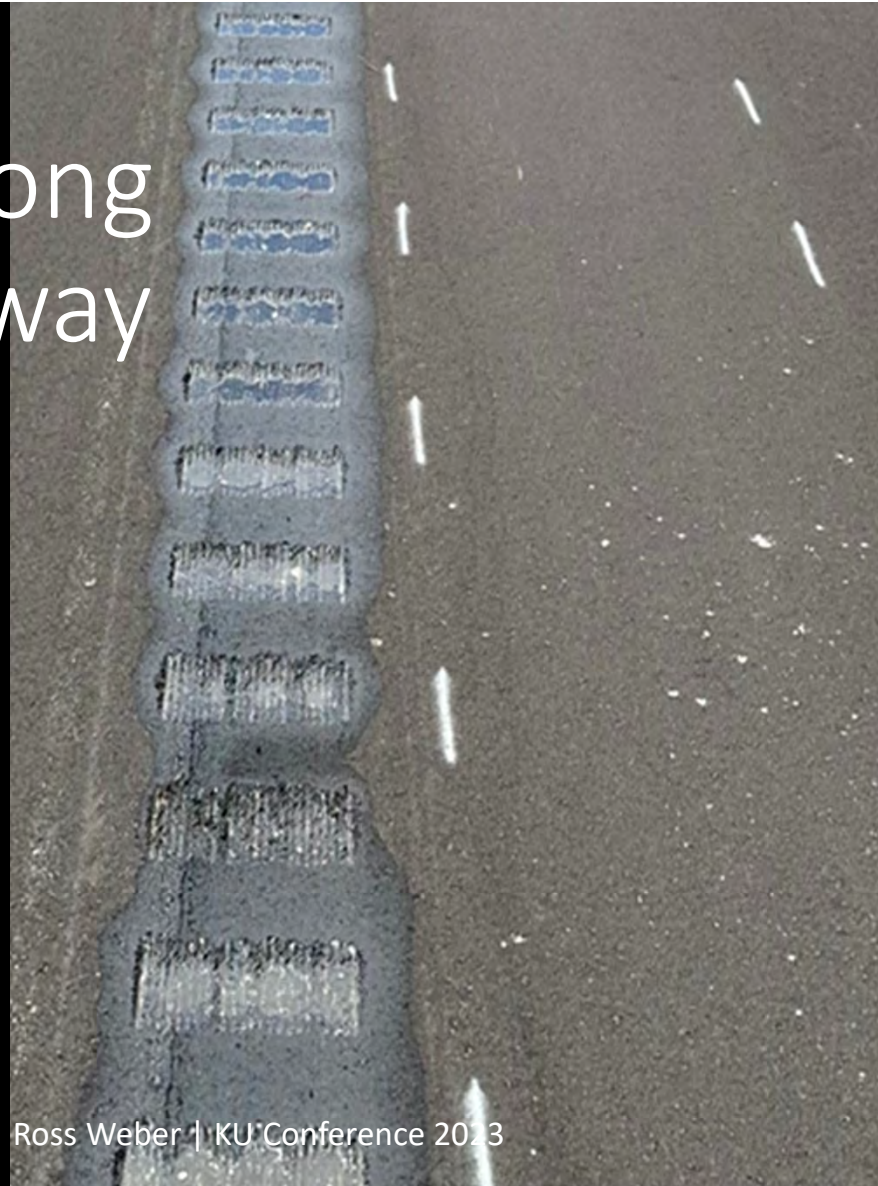
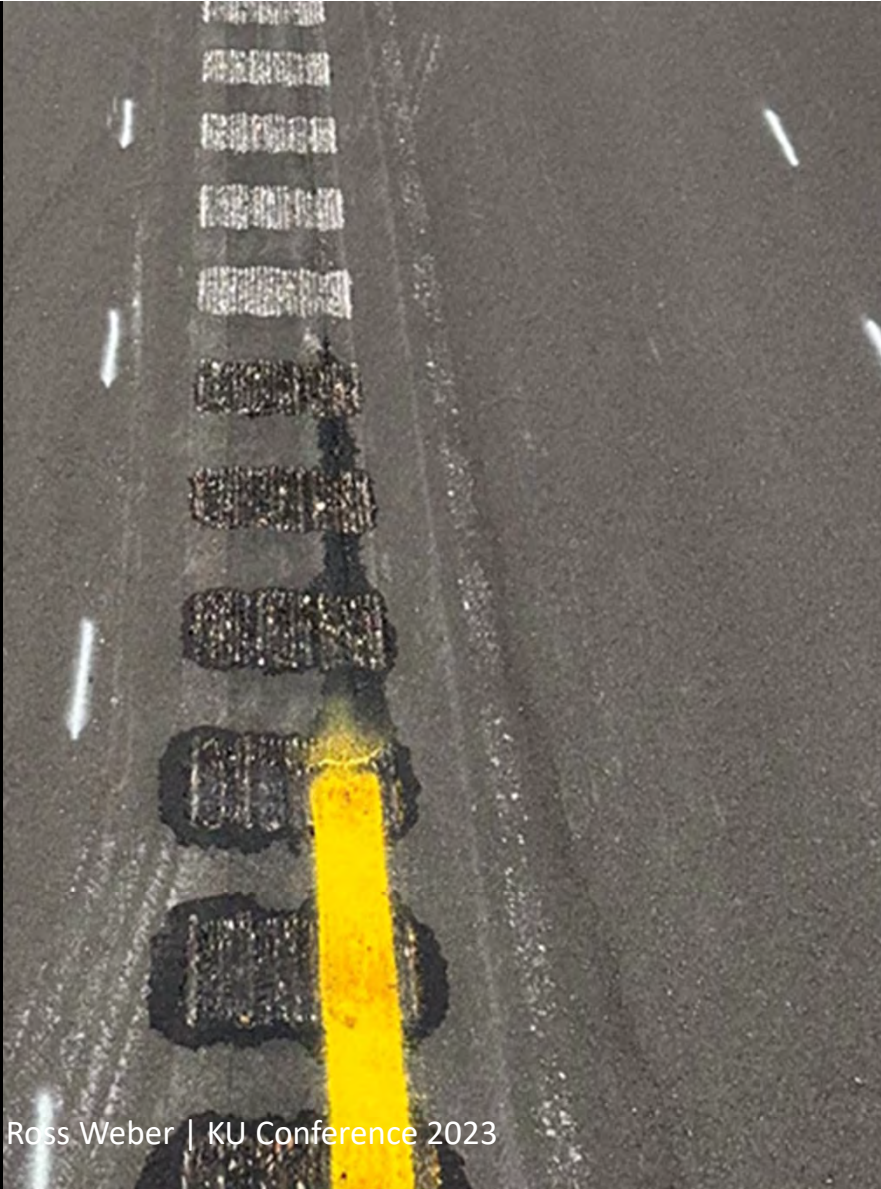
Stands water long
after the roadway
is dry

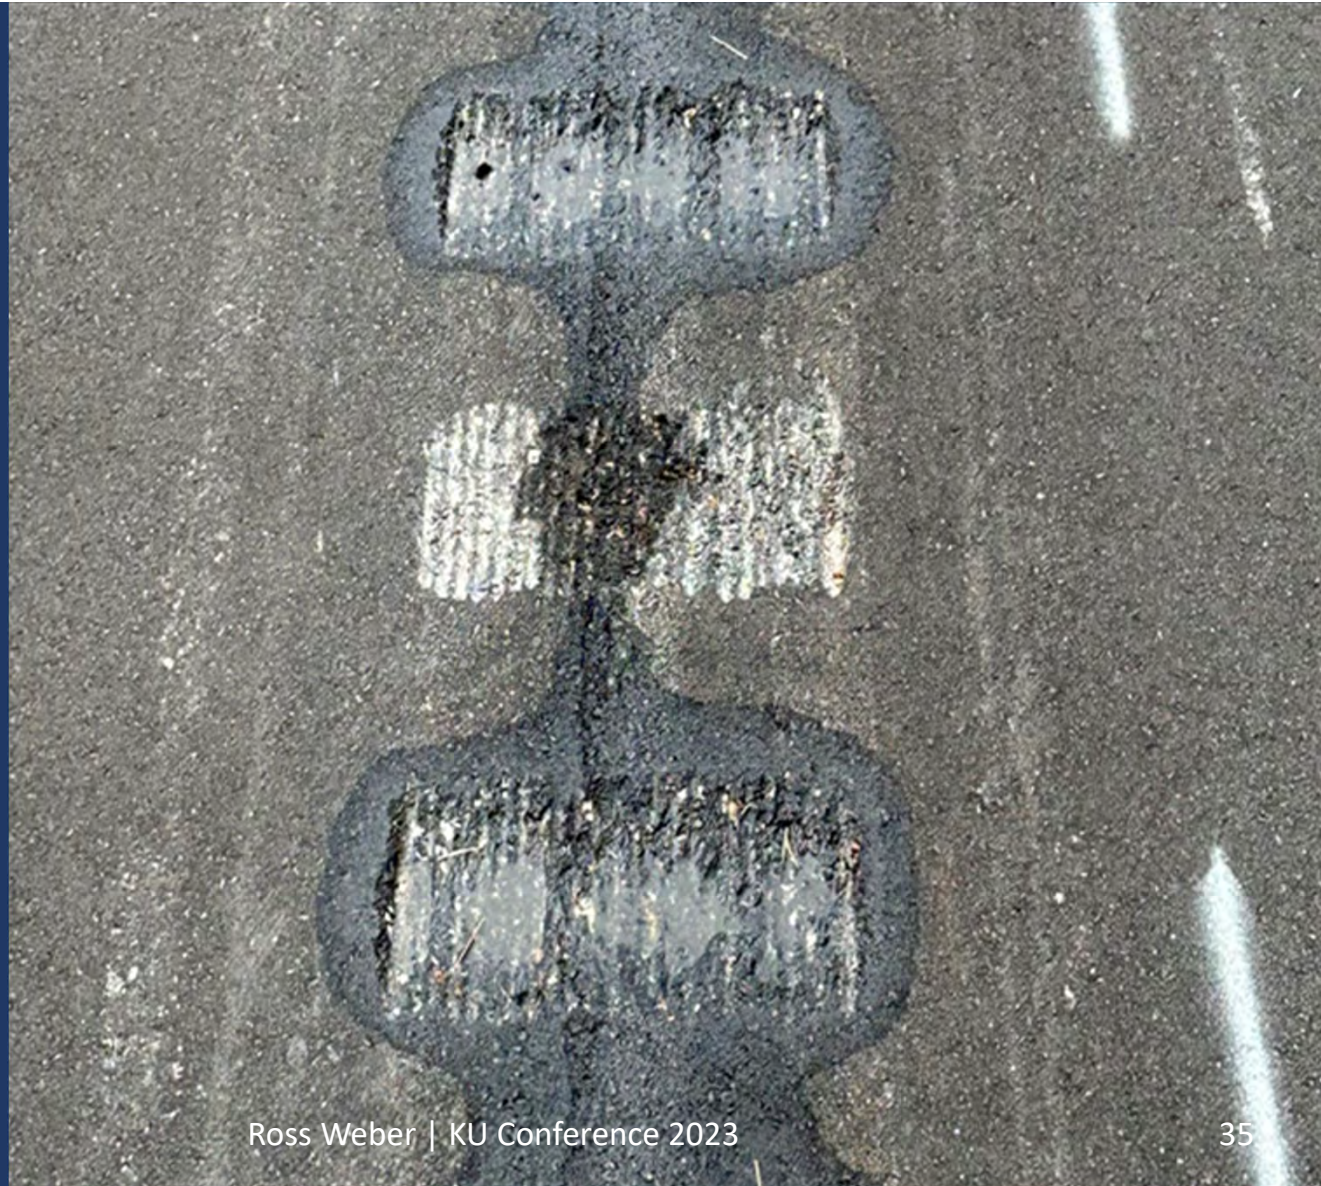
Pocket of
segregation
drained
individual cut

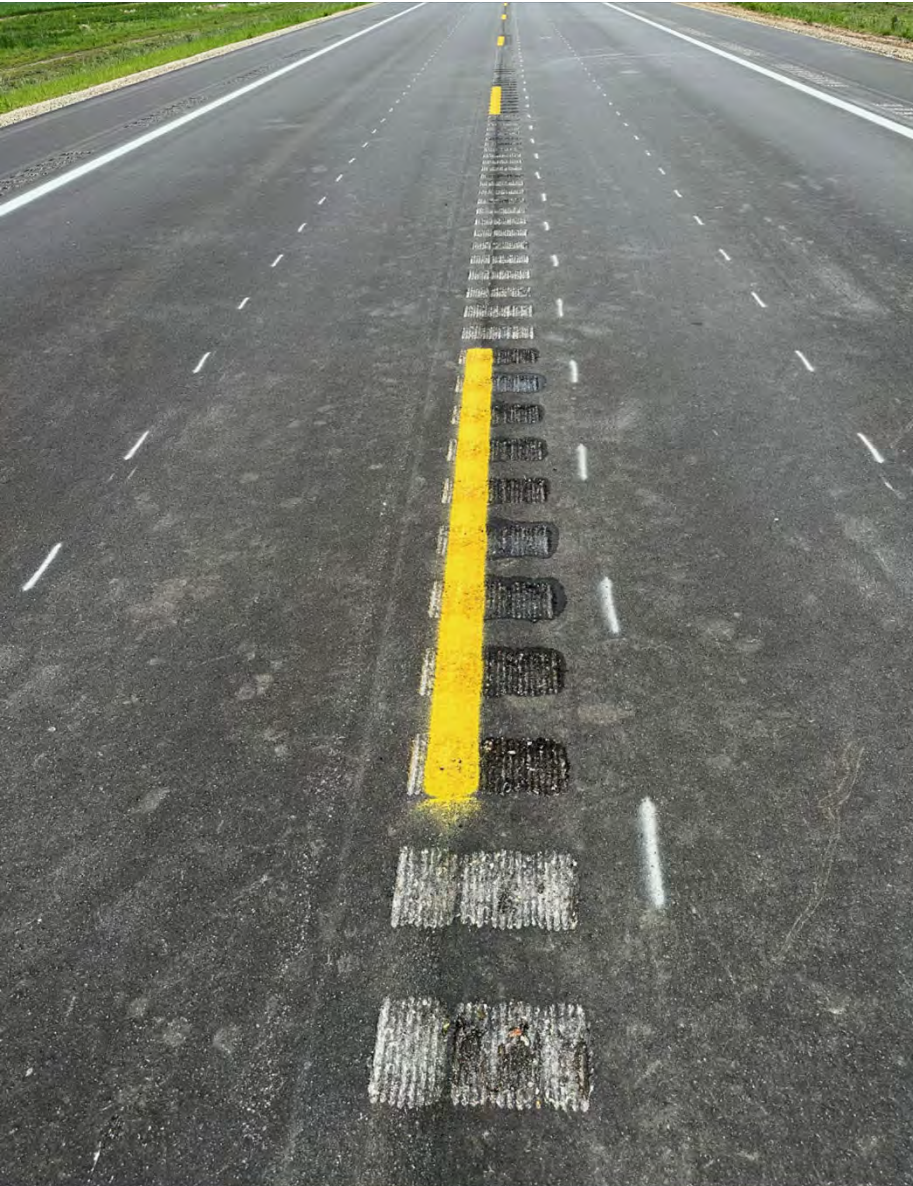
Extremely wet to
extremely dry
within same section

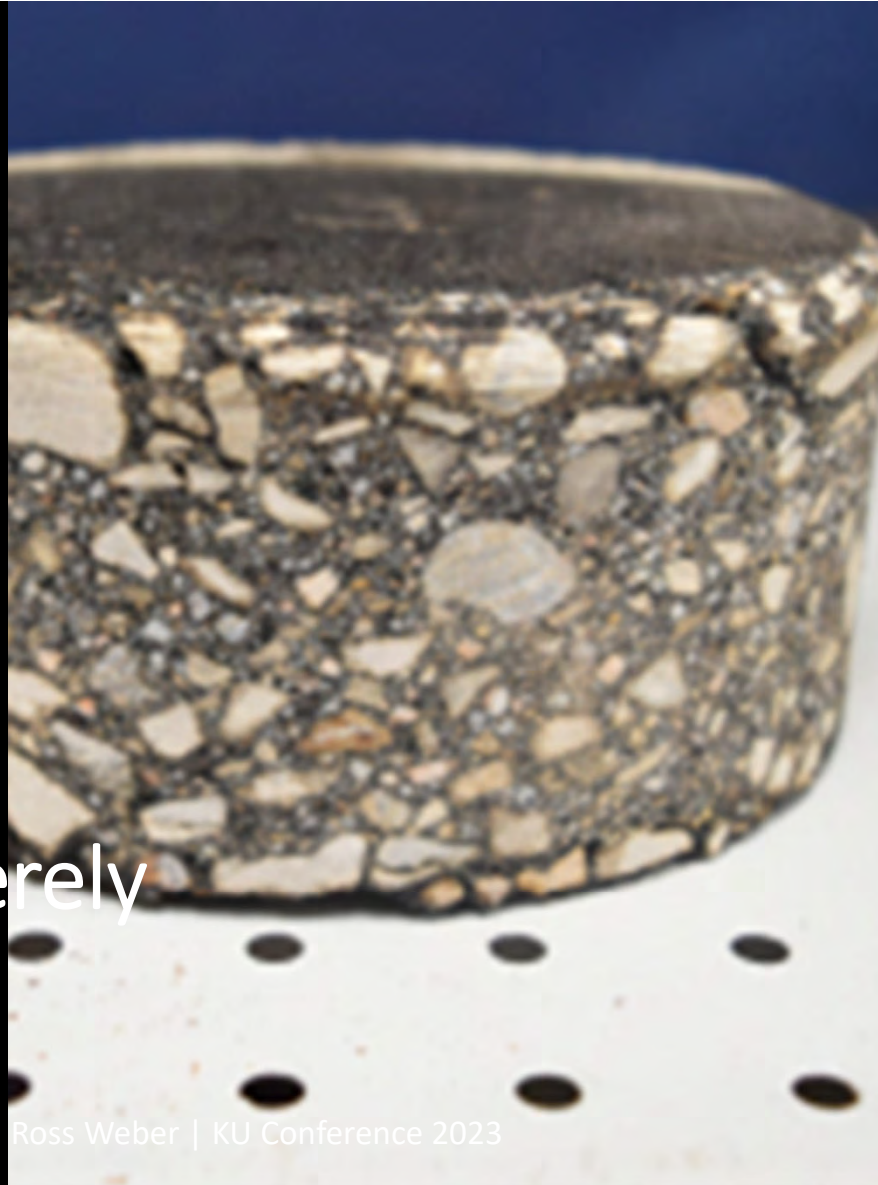
Top of core is severely damaged

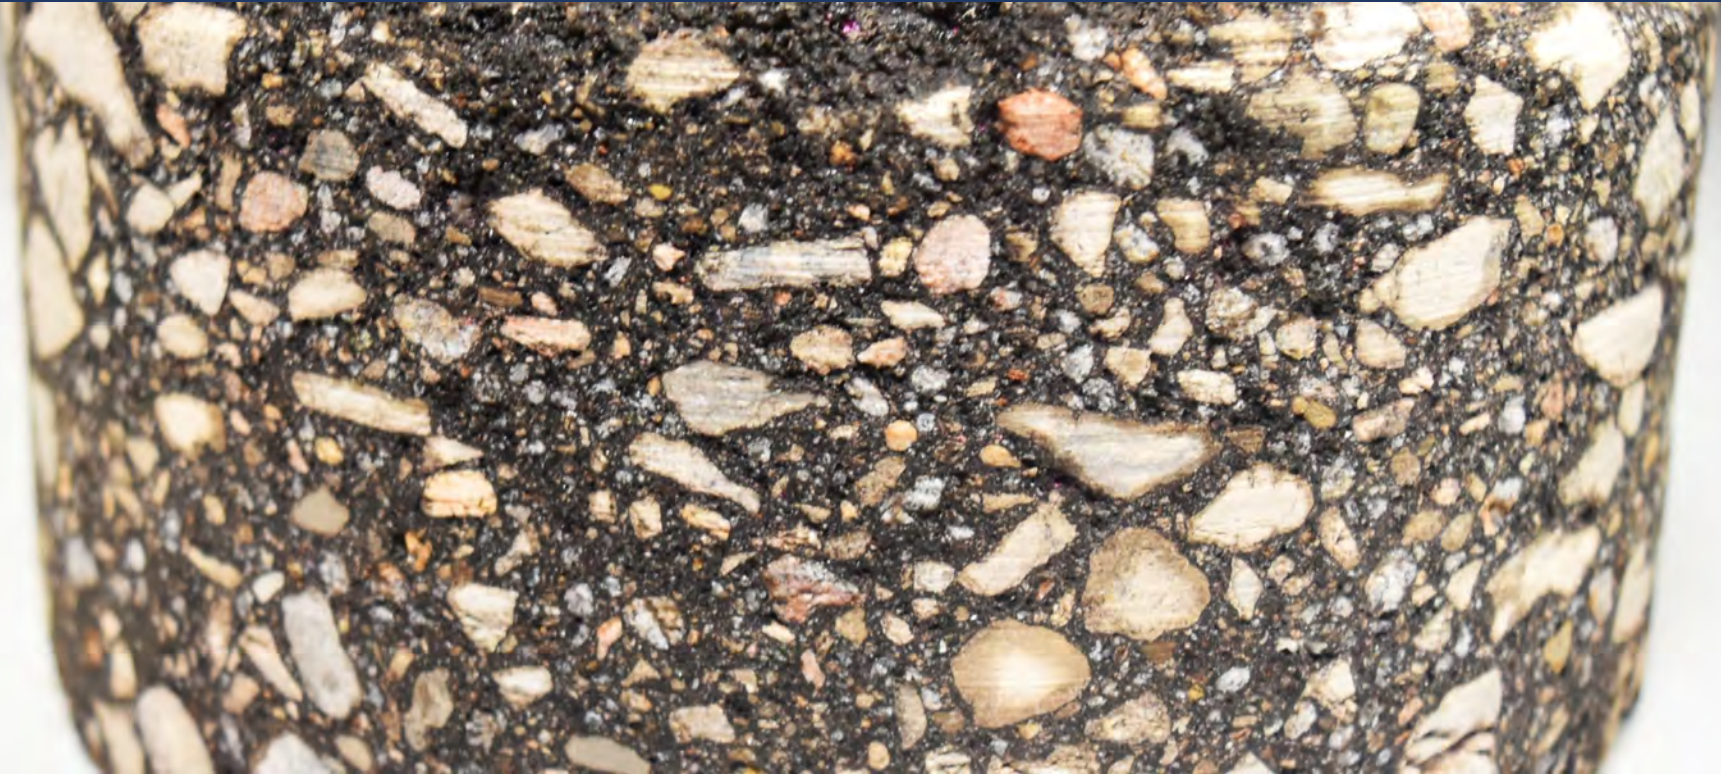
Note damage in top 1"

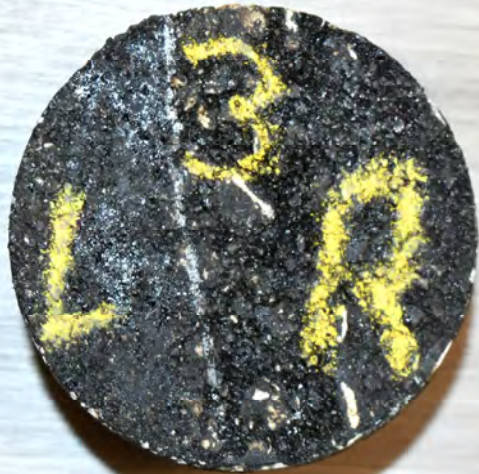
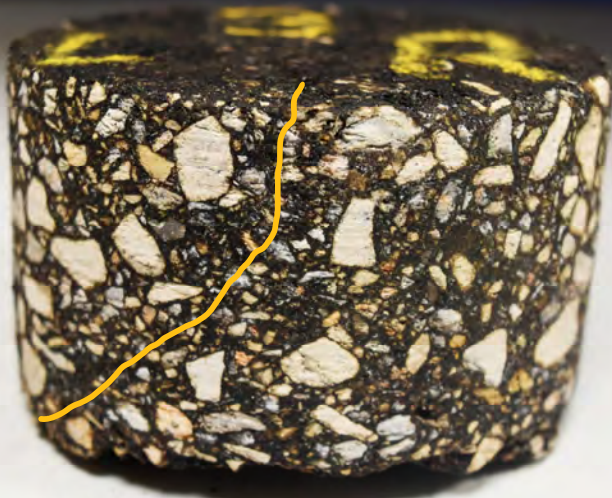
Centerline core

- Smooth on left rough on right
- Joint is tight
- Weighed up at 93%+ density
