Joint Deterioration Causes and Solutions

KU Asphalt Conference 2023

Ross Weber | KU Conference 2023

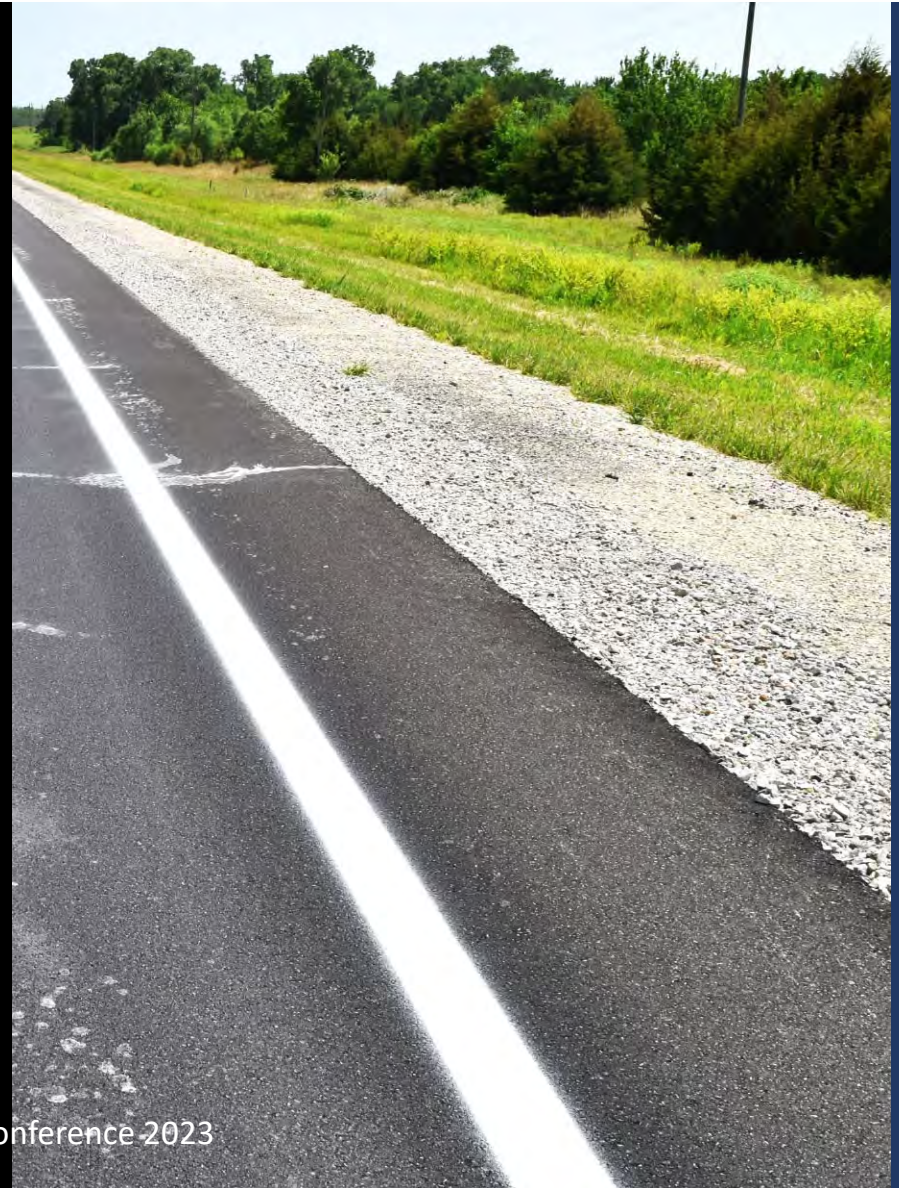
Brine from below found
the pathways in a new
overlay resulting in early
failure

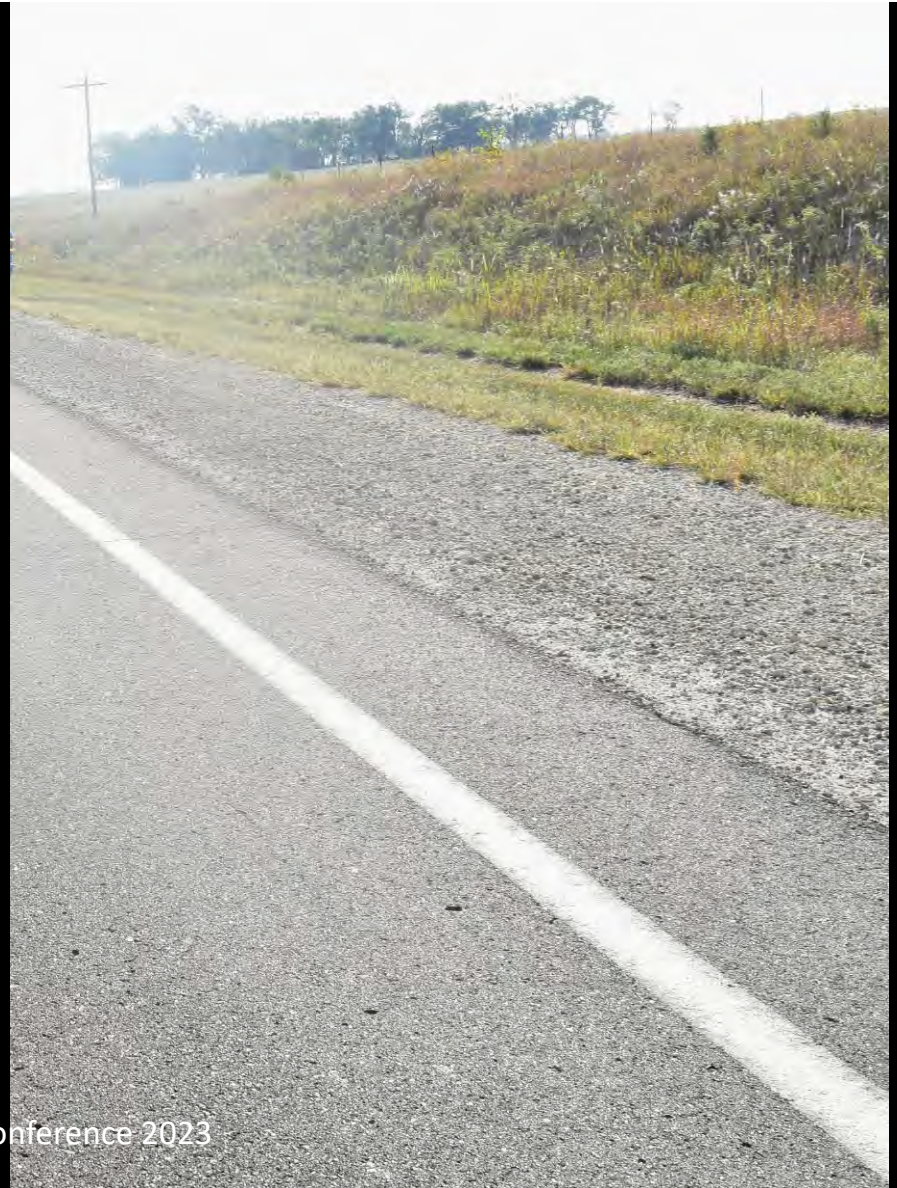
Same pattern as
the brine photo

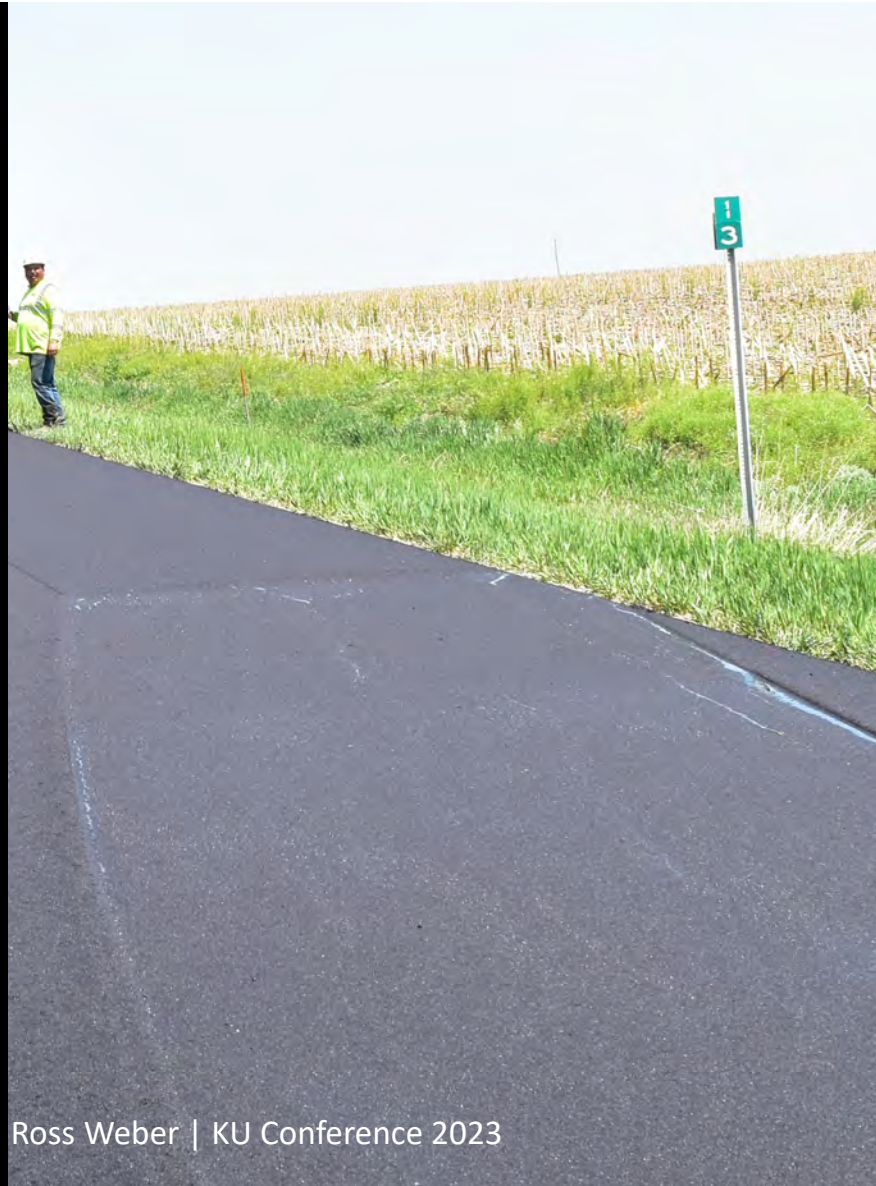
The head of material from the left doesn't belong on the right.

Roller turnout should be limited

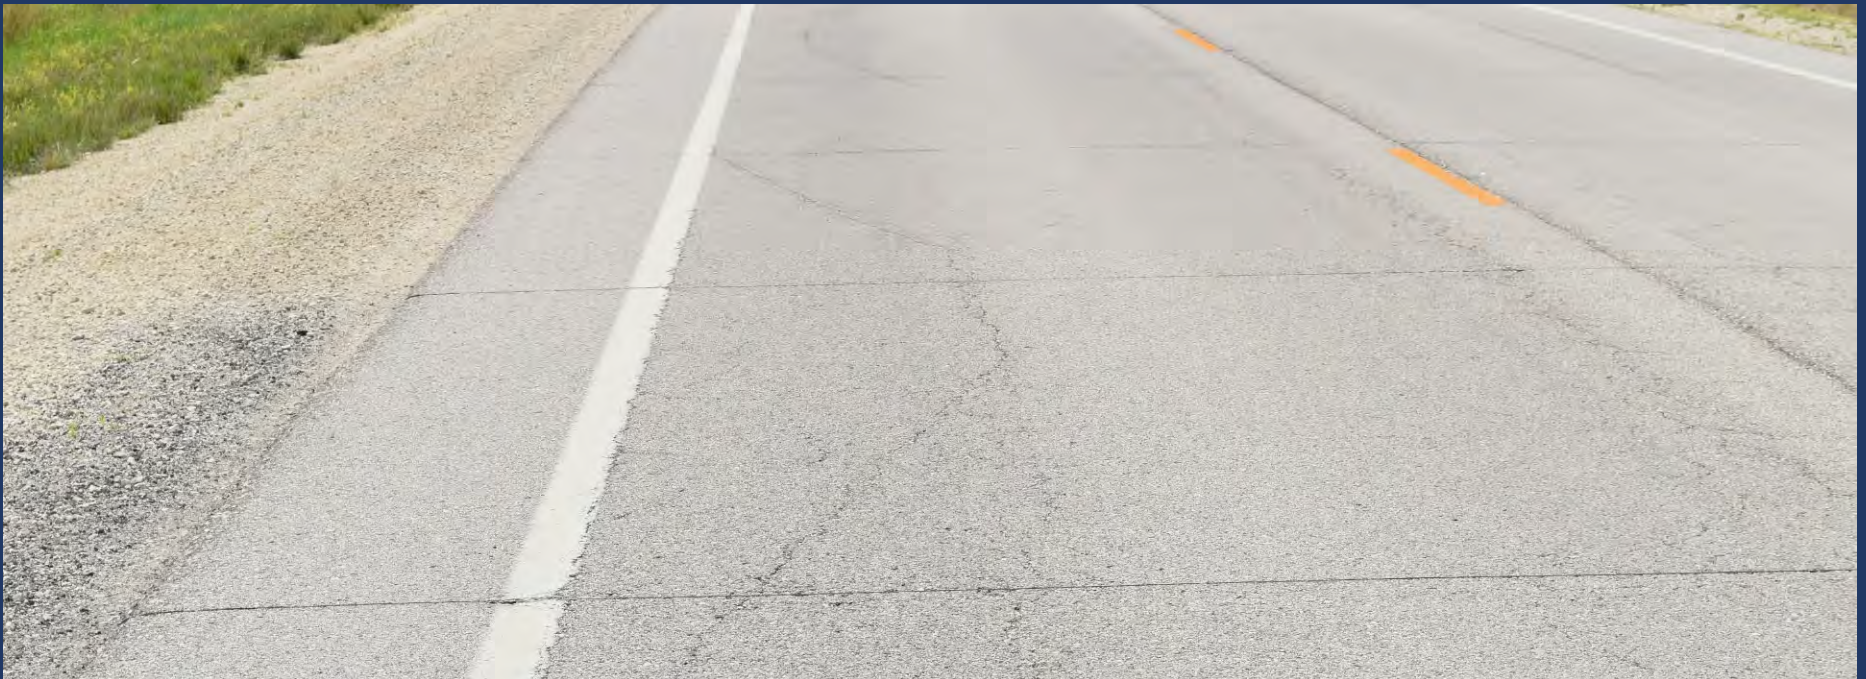
Roller turn out damages the mix

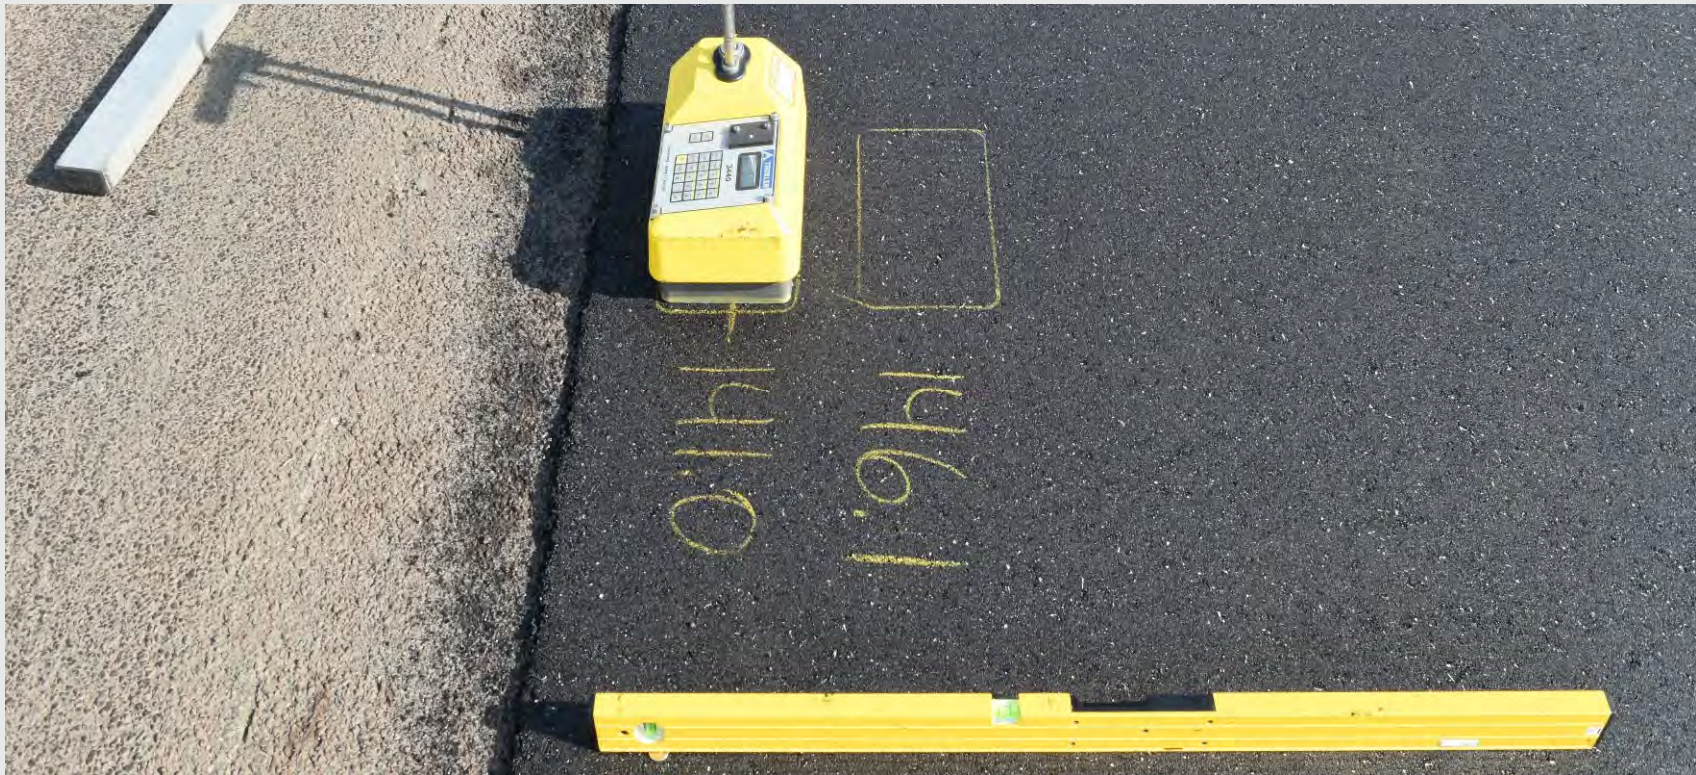
Density can be great and fall at the joint

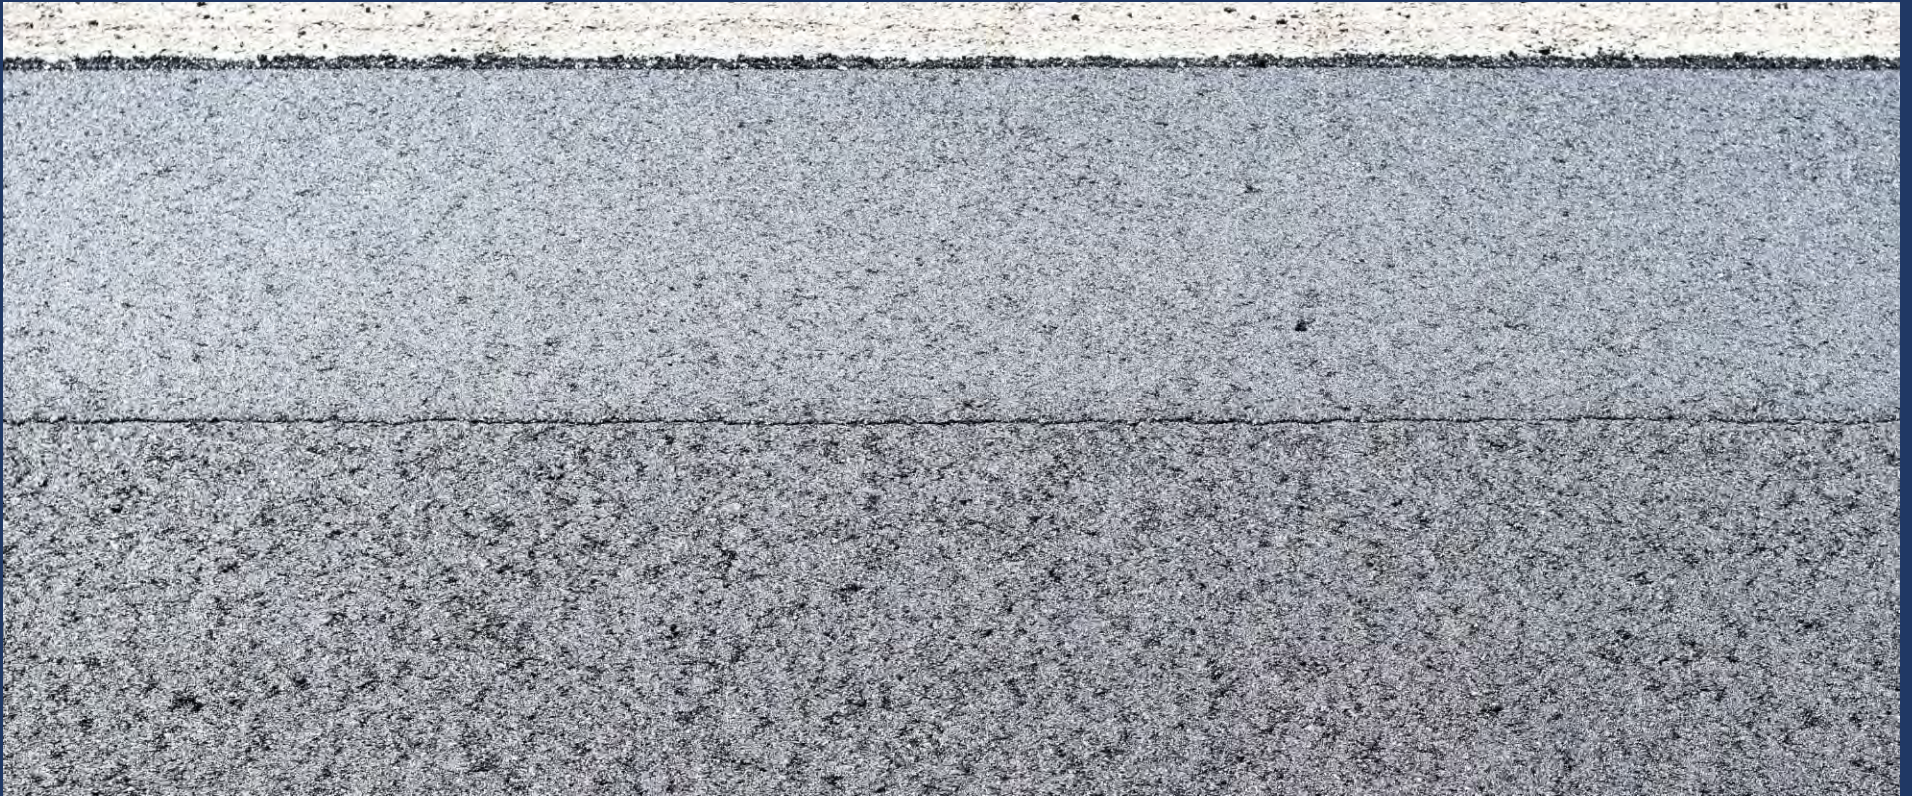
Raised extension to improve joint density

This may improve the joint at the expense of the wheel path

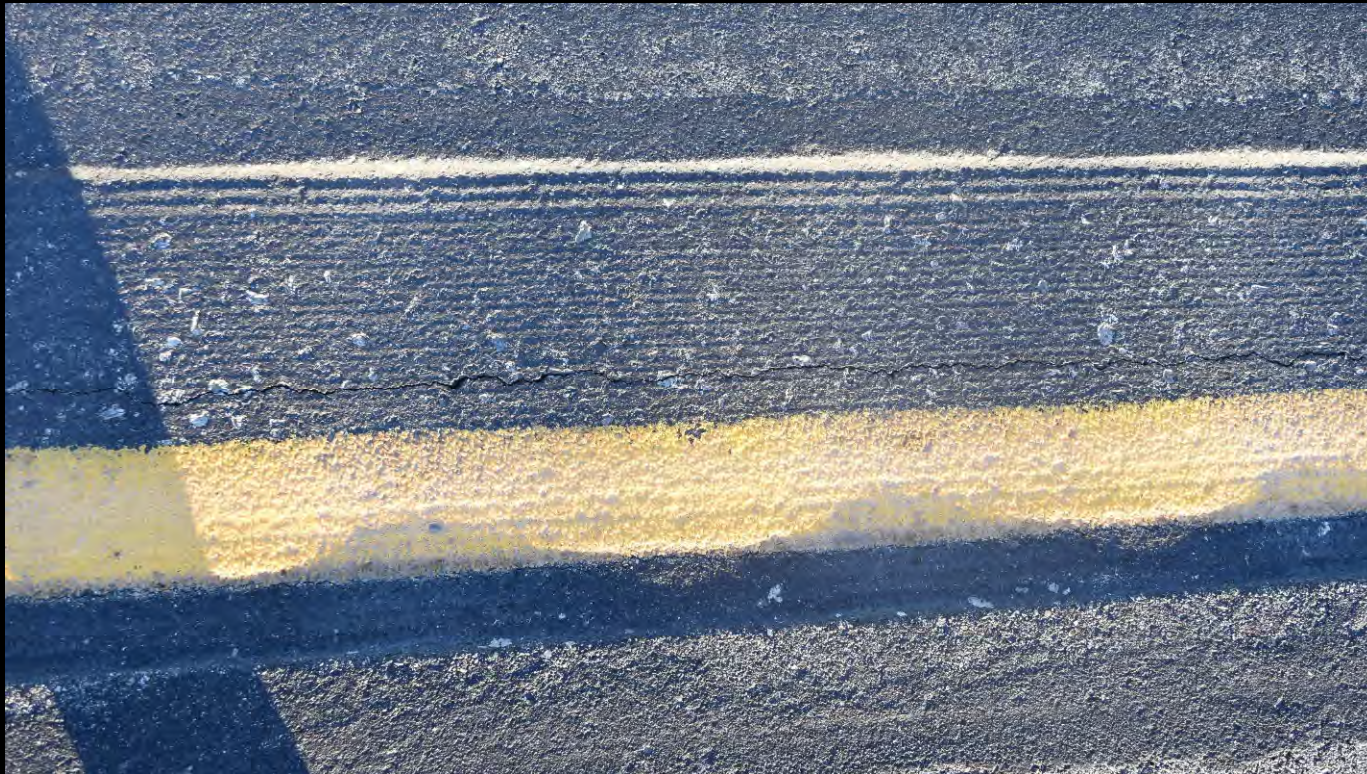
Sinusoidal with crack after a year

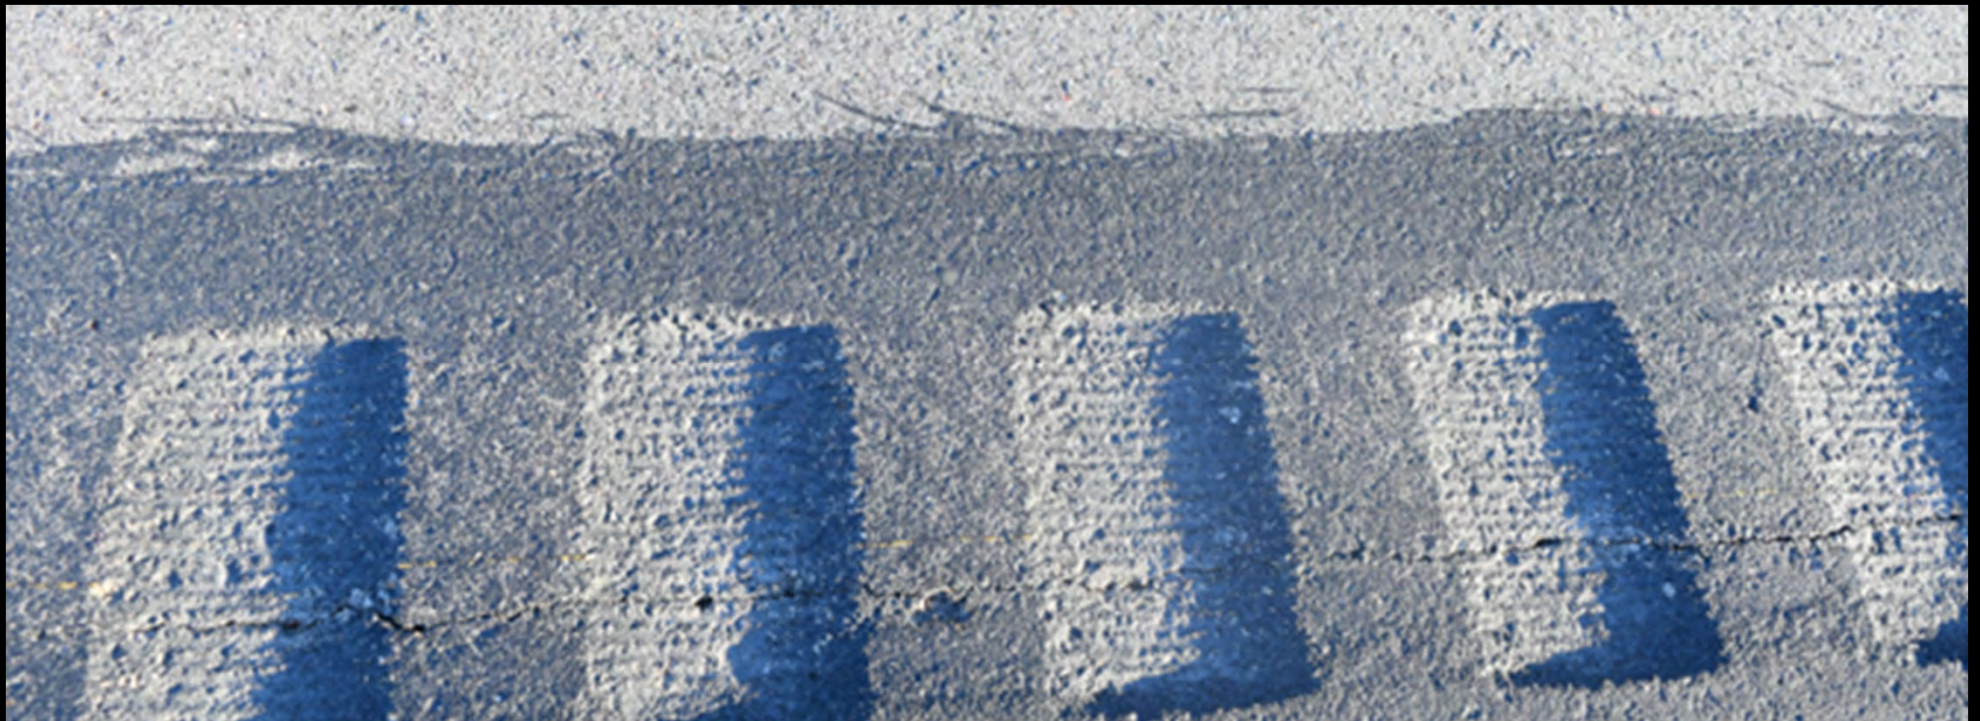
Open crack even with mastic applied
