Field Observations Following the 2023 Turkiye-Syria Earthquakes

Rémy D. Lequesne, Ph.D., P.E., FACI

Observed Damage: Problematic Reinforcement Details

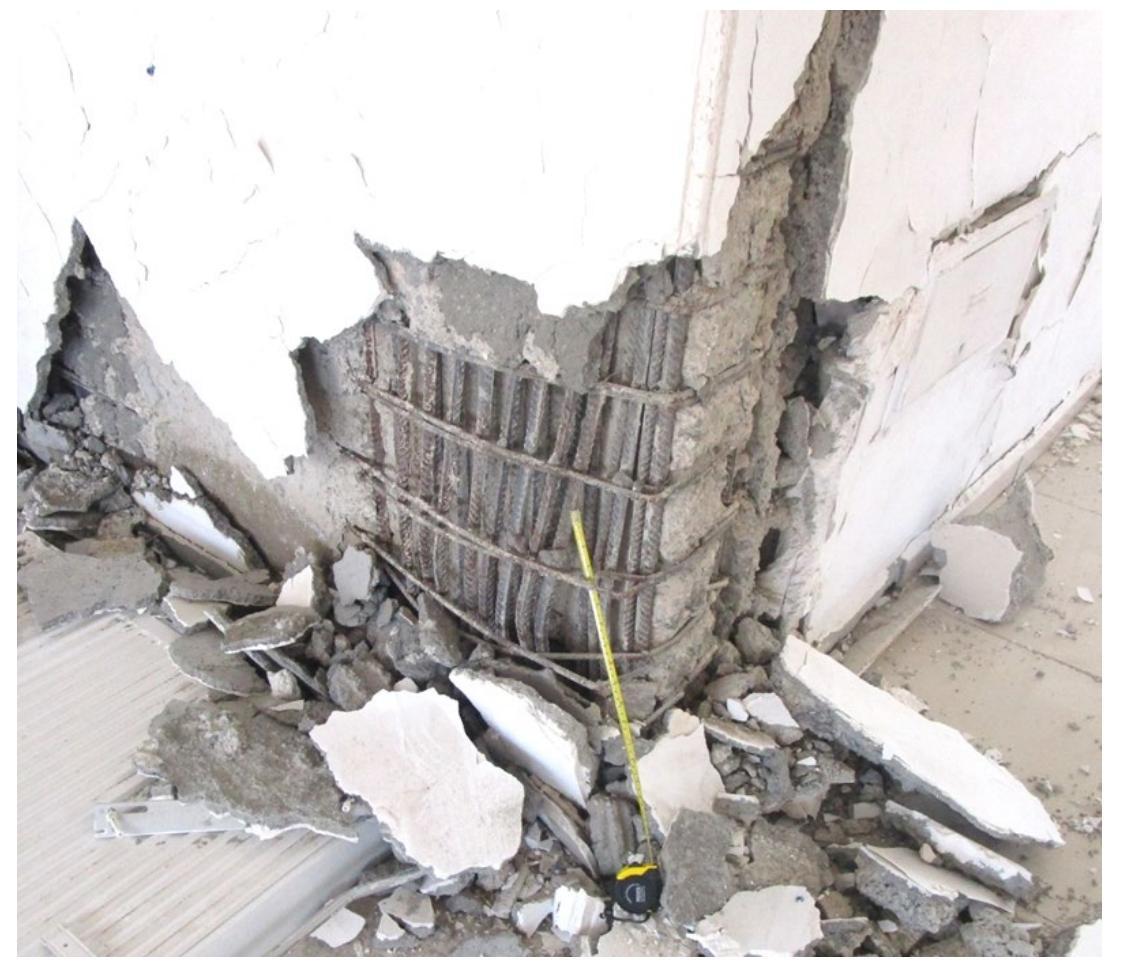
Concrete cover or longitudinal bar spacing smaller than required

Lack of crossties

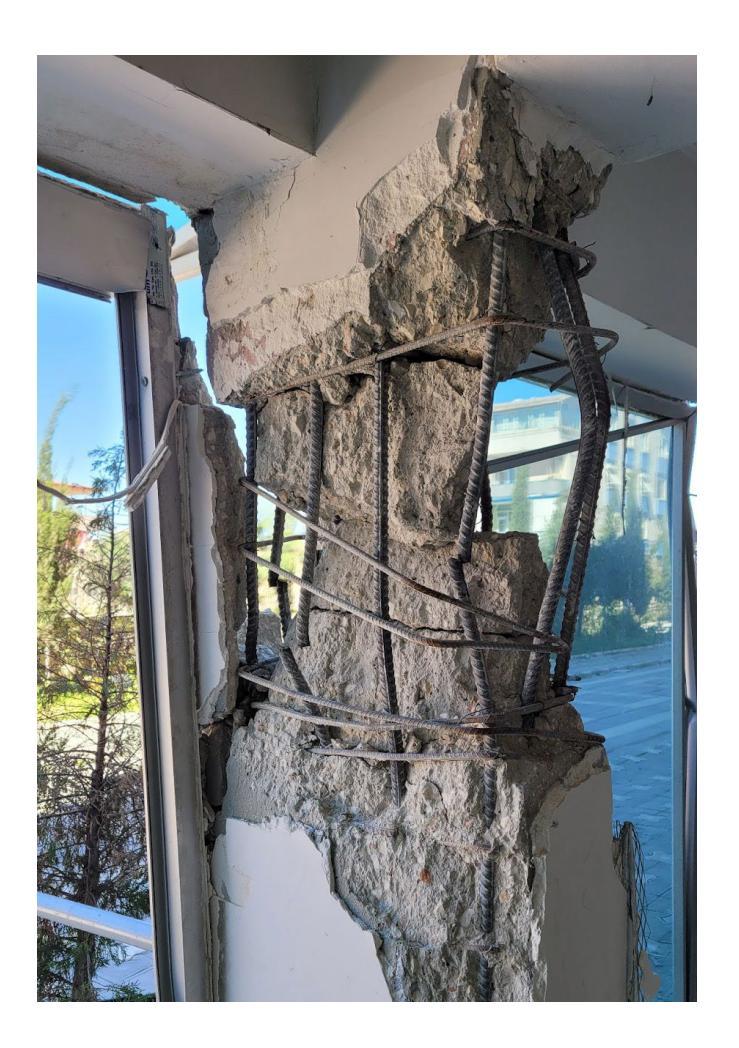
Lack of 135-degree hooks

Widely spaced transverse reinforcement around smalldiameter longitudinal bars

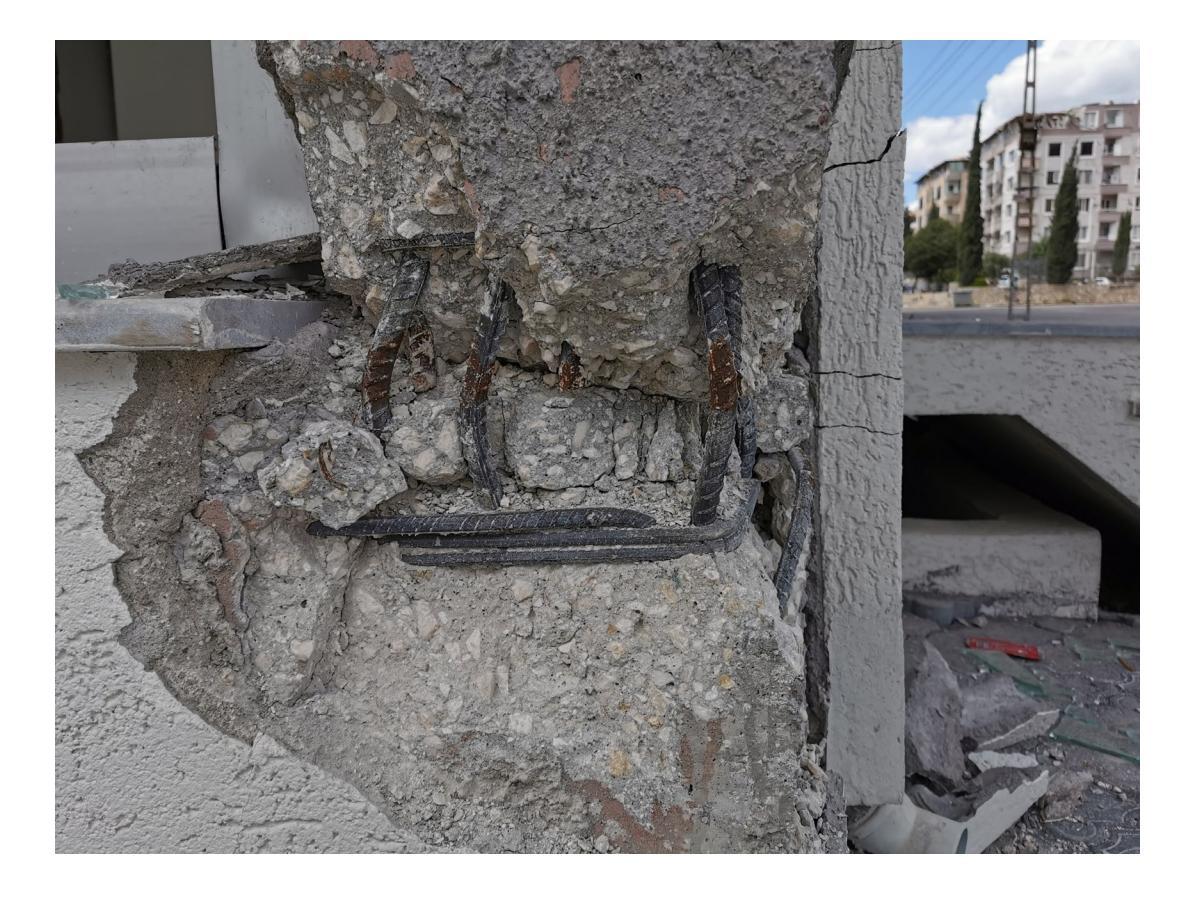
Widely spaced transverse reinforcement at cold joints

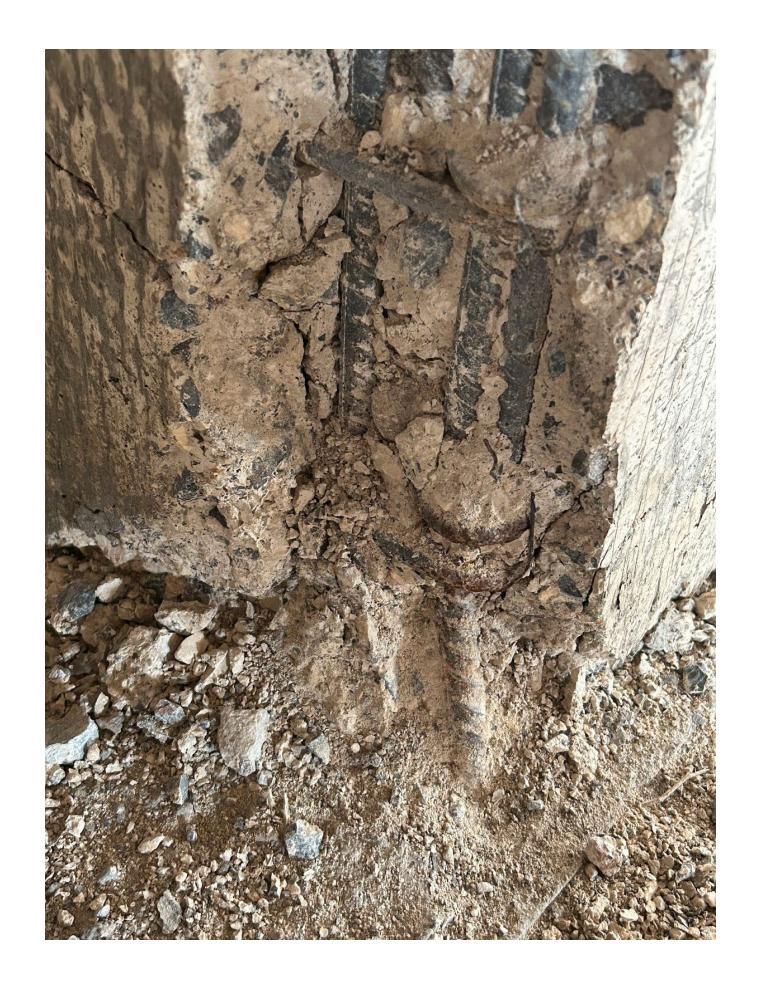
Offset-bent longitudinal bars (socalled "dog-Leg" detail) at the base of columns/walls

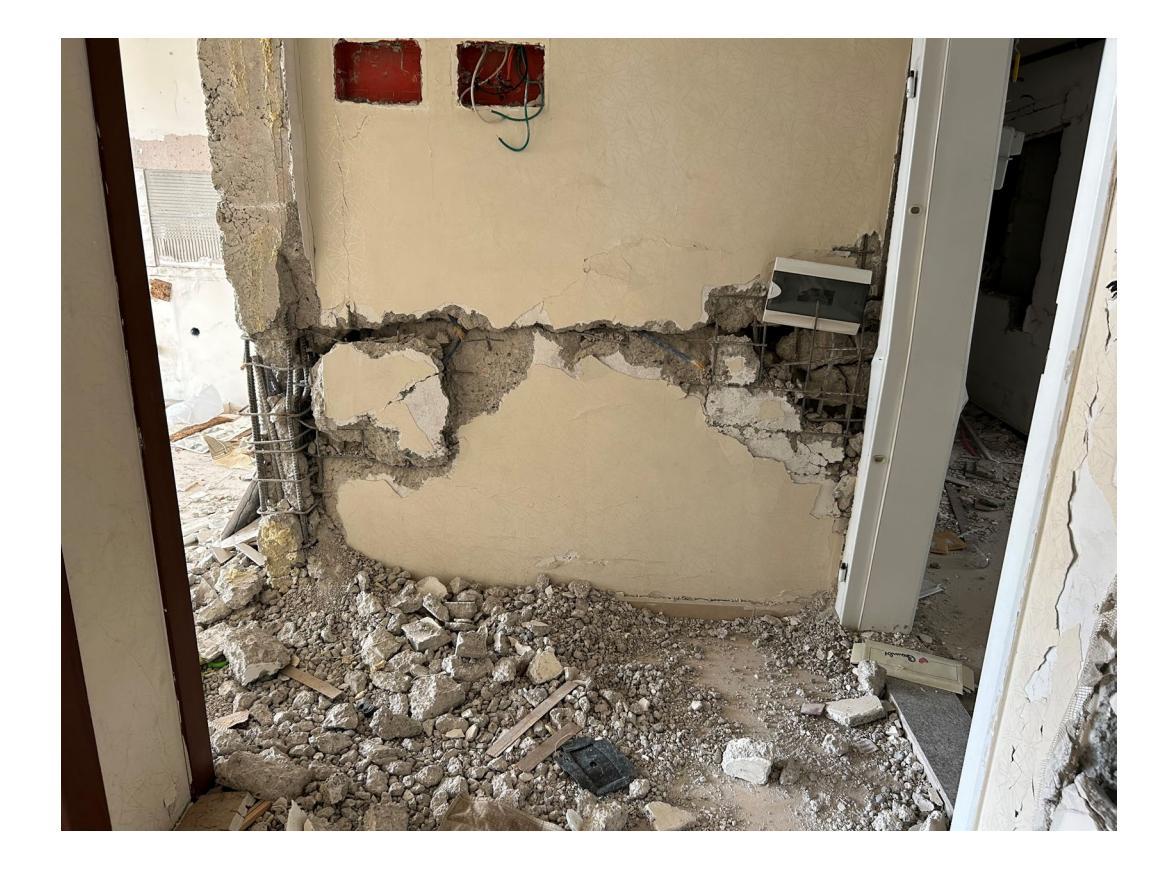
Lap splices at column and wall bases

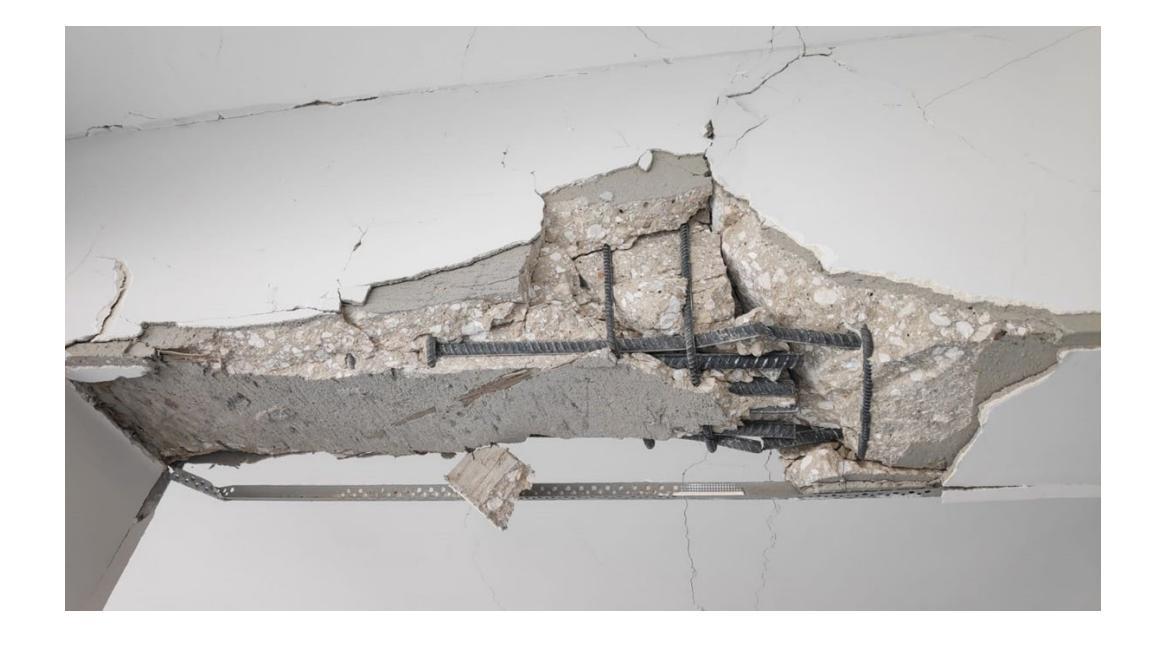
Bar terminations in beams

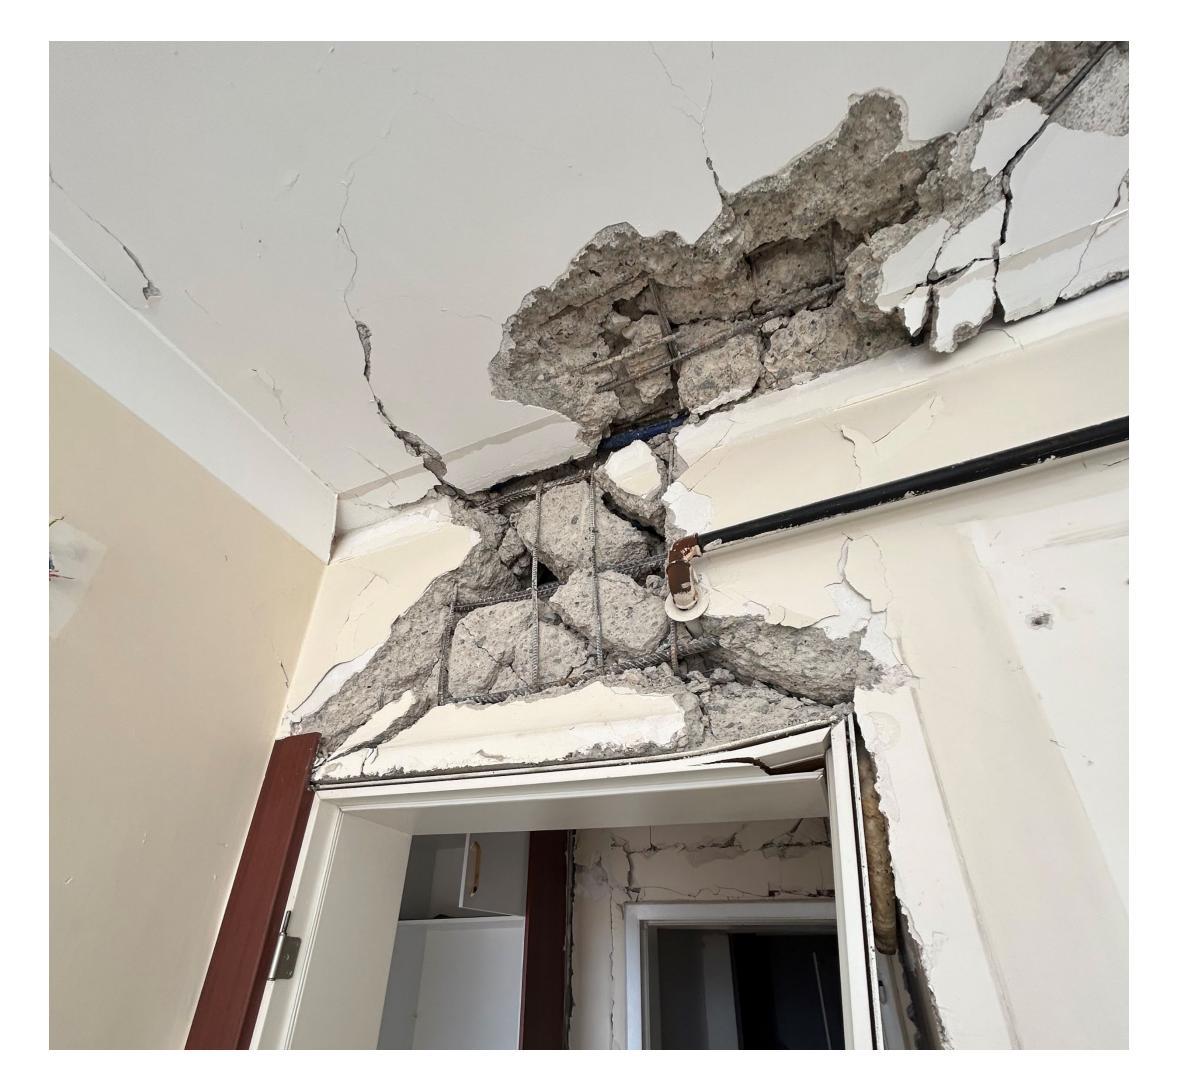
Detailing of short "nonparticipating" beams

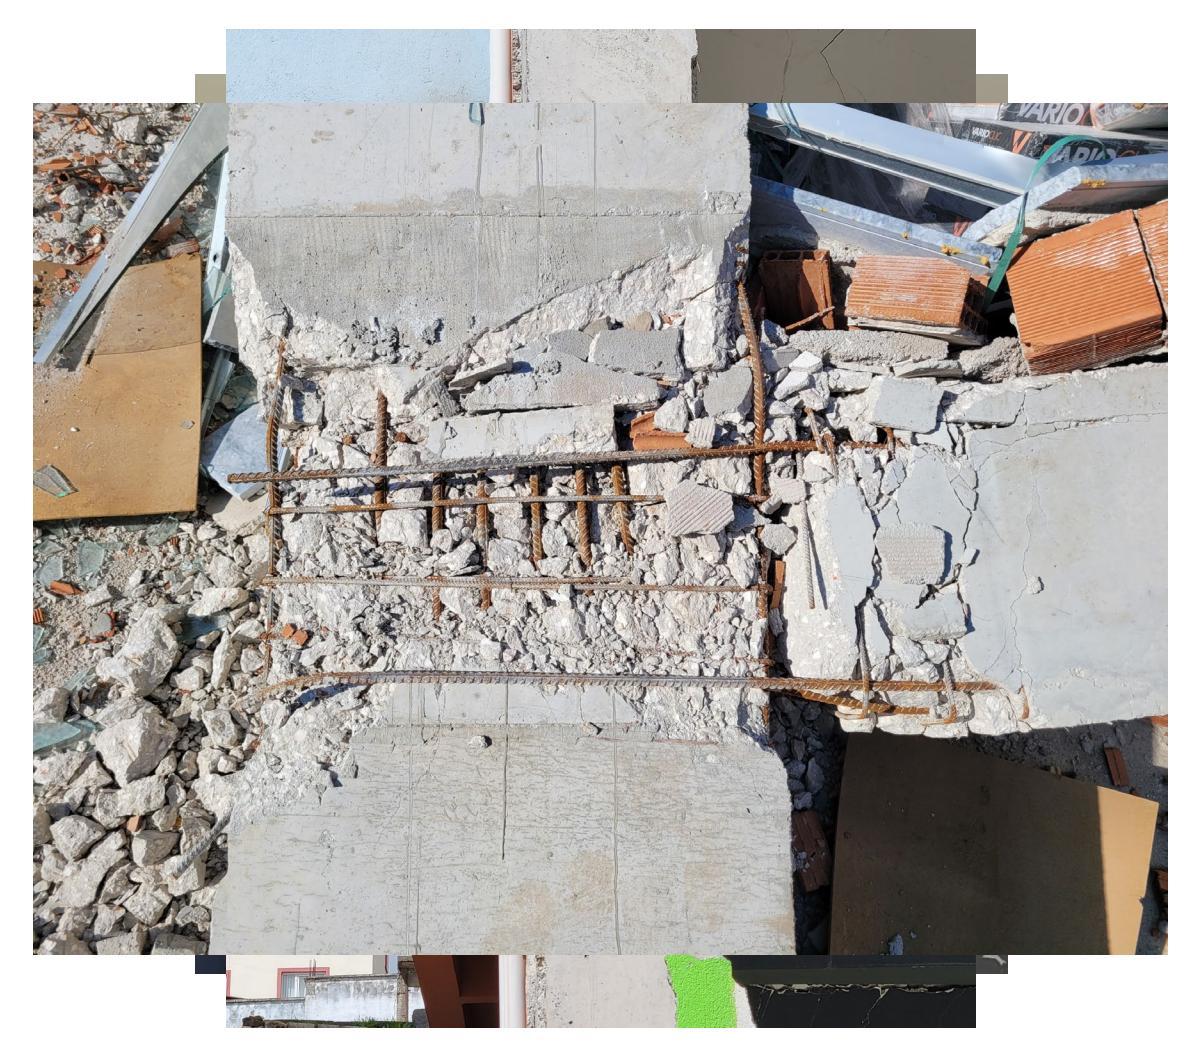
Unconfined beam bars in beamcolumn joints

ACI 318 prohibits in SMF; Consider extending to "nonparticipating", IMF, and OMF
